## HydraWrap® (Fiber Reinforced Polymer)

*Power Generation*

The challenge was to rehabilitate the deteriorated cooling water piping due to through wall leaks.

The solution utilized the HydraWrap Structural Composite Repair System.

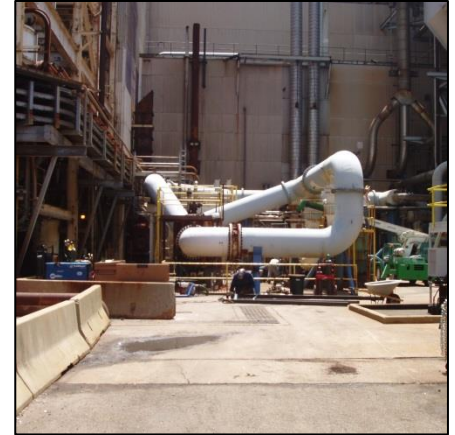
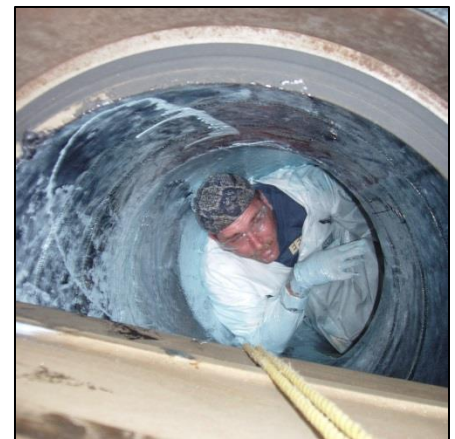
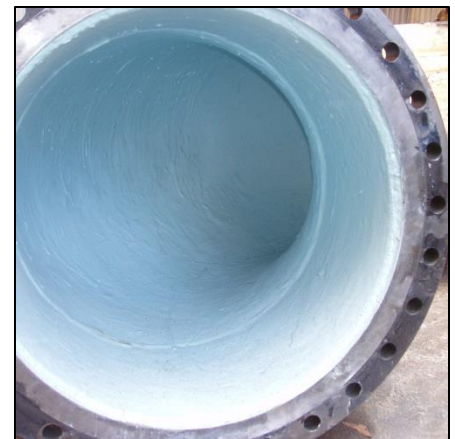
The project required the removal of the sometimes tenacious existing coatings. Selected pipe spools were removed and other openings were provided to allow access into the piping. The substrate was prepared by grit blasting. The piping system was repaired by applying an epoxy primer, layers of carbon fiber and a top coat. The entire process was complete in the allotted timeframe, and was a cost-effective repair option.
