## HydraTite® Internal Joint Seal

Infrastructure repair/site remediation/Environmental

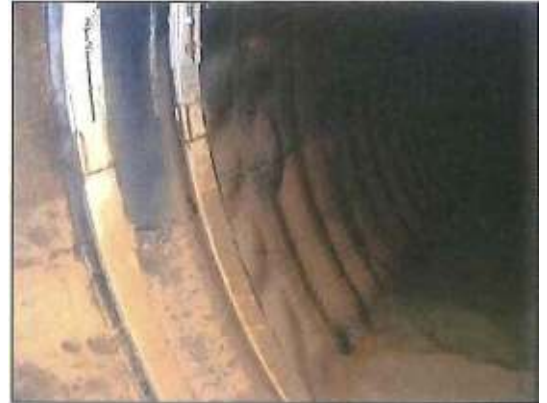
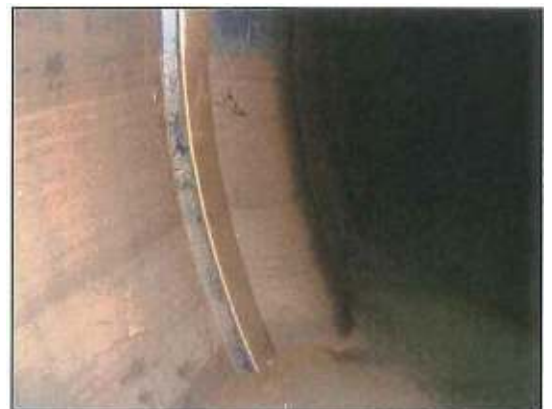
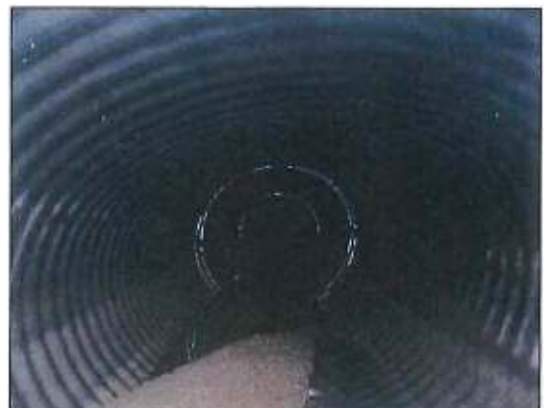
The goal was to eliminate groundwater infiltration with the HydraTite internal joint seal installed at every pipe joint. The versatility of the HydraTite seal was able to cover the pipe ovality while enabling a secure seal to the pipe joints. In three days - sixteen joints were completely sealed and repaired. A post installation analysis of the groundwater had revealed there were no more containments in the pipe. The project was completed quickly and correctly eliminating environmental hazards utilizing the HydraTite Seal.
