INTERNAL PIPE

# HydraTite®

JOINT SEAL

**Market**  
*Industrial*

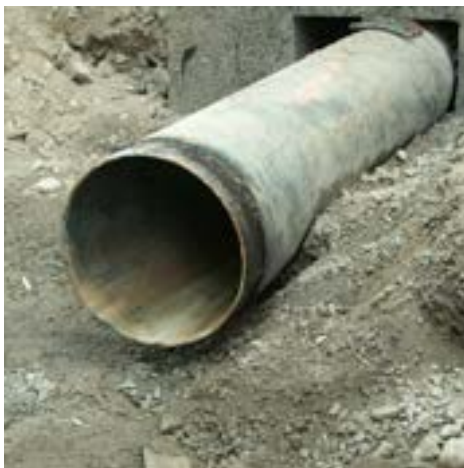
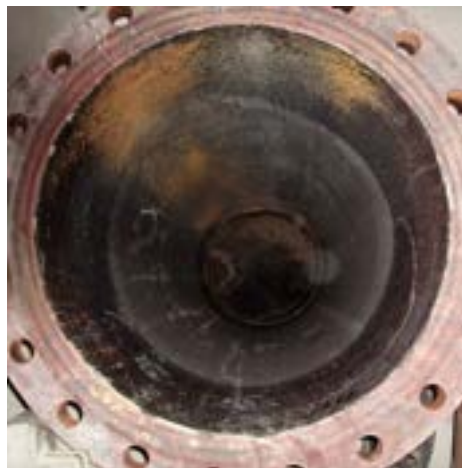
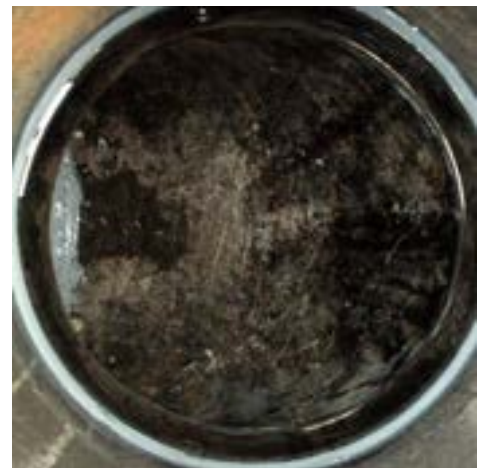
The existing concrete mortar was removed in the areas of the sealing surface to create a seal between the seal and ductile iron pipe. The HydraTite® seal was installed and, in areas where the concrete mortar was removed outside the seal area, and an epoxy filler was used to fill the voids and provide protection to any exposed areas of the ductile iron pipe. All components used were NSF 61 approved.

HydraTech was able to provide the HydraTite® Internal Pipe Joint Seals to repair the leaking joints. The HydraTite seals provided an economical repair method that was a better choice than replacing with a new fitting, as HydraTite's® installation did not necessitate the removal of installed auxiliary equipment and the demolition of recently constructed foundations.
