INTERNAL PIPE

# HydraTite®

JOINT SEAL

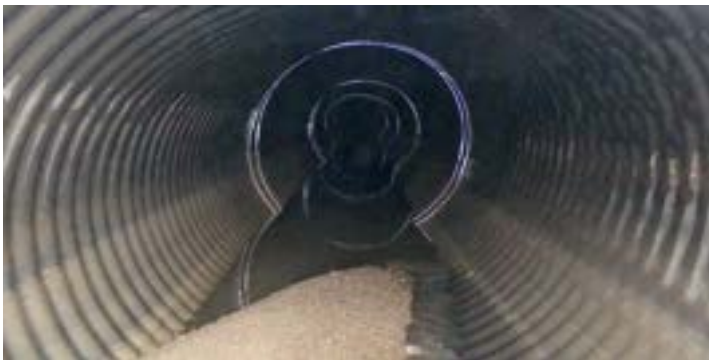
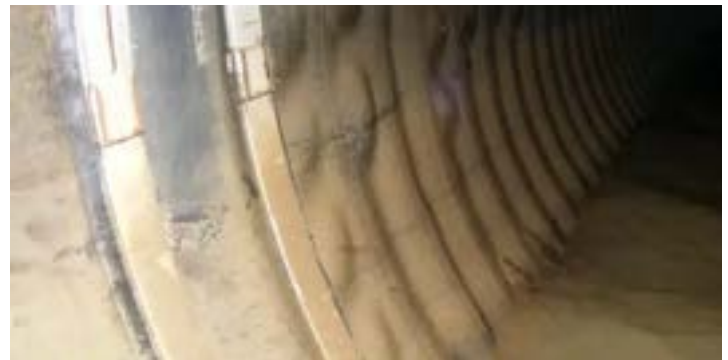
The goal was to eliminate groundwater infiltration with the HydraTite internal joint seal installed at every pipe joint. The versatility of the HydraTite seal was able to cover the pipe ovality while enabling a secure seal to the pipe joints. In three days, sixteen joints were completely sealed and repaired. A post installation analysis of the groundwater had revealed there were no more containments in the pipe. The project was completed quickly and correctly eliminating environmental hazards utilizing the HydraTite Seal.
