INTERNAL PIPE

# HydraTite®

JOINT SEAL

Power

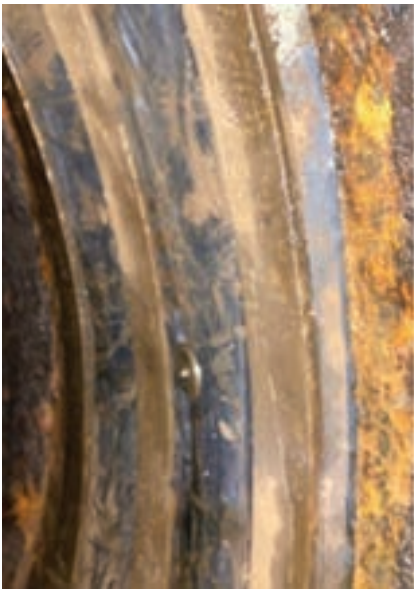
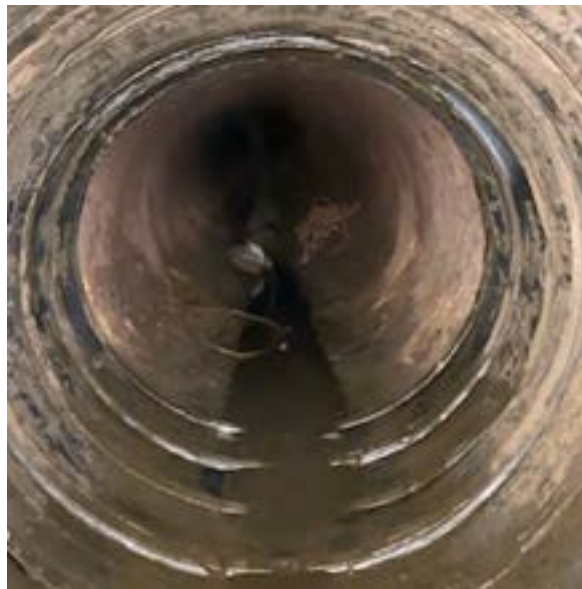
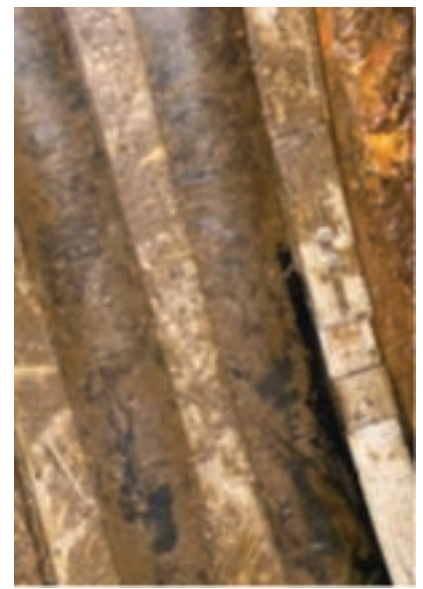
High-pressure water and grinding were utilized to remove existing pipe coating. This surface preparation would ensure a watertight seal. The defective coupling was repaired with a HydraTite joint seal utilizing a backing plate. The HydraTite seal provided a flexible watertight seal through proper compression of the EPDM membrane. The joint located upstream with excessive offset was repaired using an interlocking sleeve of HydraTite seals. Each joint repair was completed in a day.
