INTERNAL PIPE

HydraTite®

JOINT SEAL

Water / Utilities

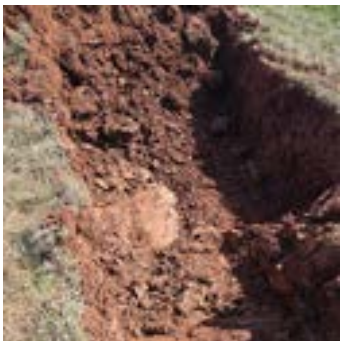
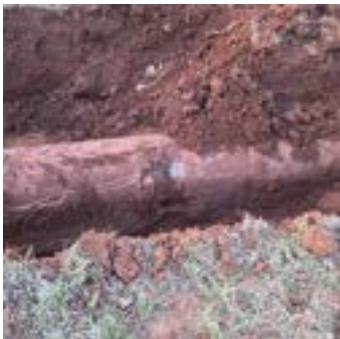
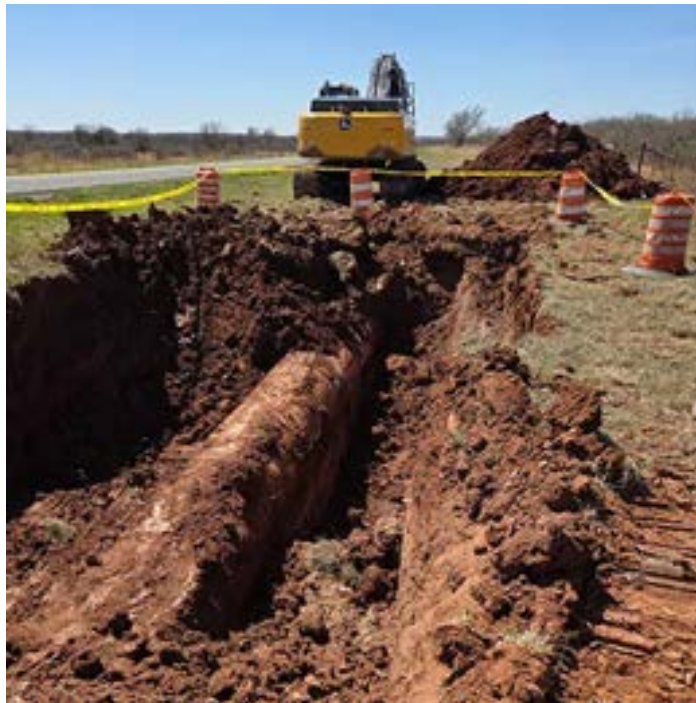
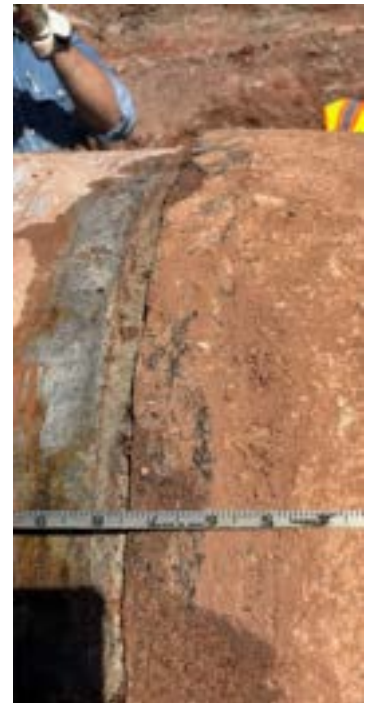
Two double-wide HydraTite® seals were selected to provide extended coverage over the leaking joints. Each seal was installed using three stainless steel retaining bands, delivering uniform compression and a long-term mechanical seal.

Once located, both leaking joints were sealed using the custom double-wide HydraTite® seals. The installation required no additional surface preparation and was completed efficiently despite the challenging access conditions. The entire installation was completed in approximately 2.5 hours.
