INTERNAL PIPE

# HydraTite®

JOINT SEAL

## Market

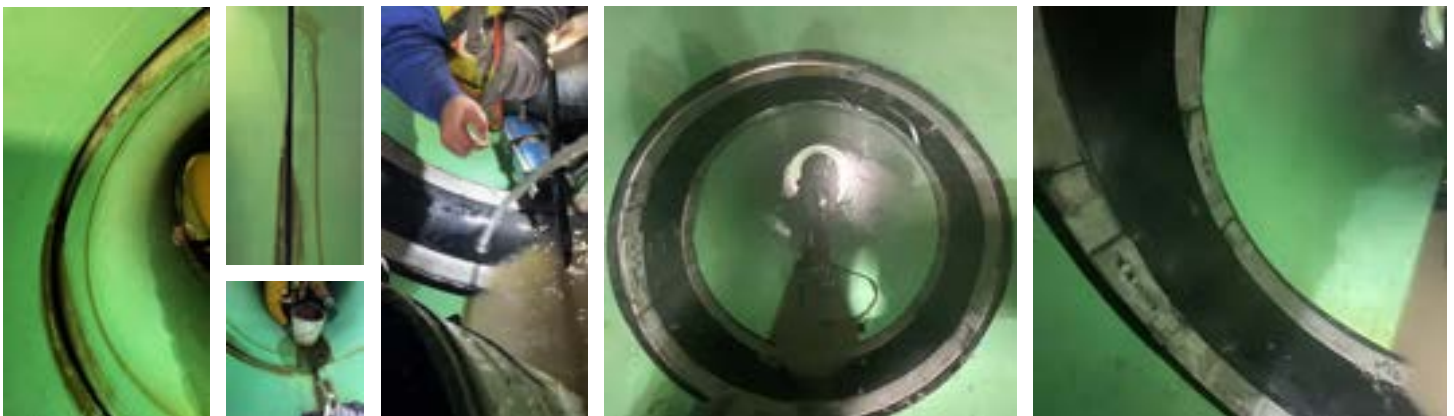
HydraTech's technicians rehabilitated this pipe with the HydraTite seal incredibly fast without disturbing the above-ground construction. This seal will prevent this joint from leaking for a fraction of the cost associated with digging and replace.
