INTERNAL PIPE

# HydraTite®

JOINT SEAL

*Municipal / Sanitation*

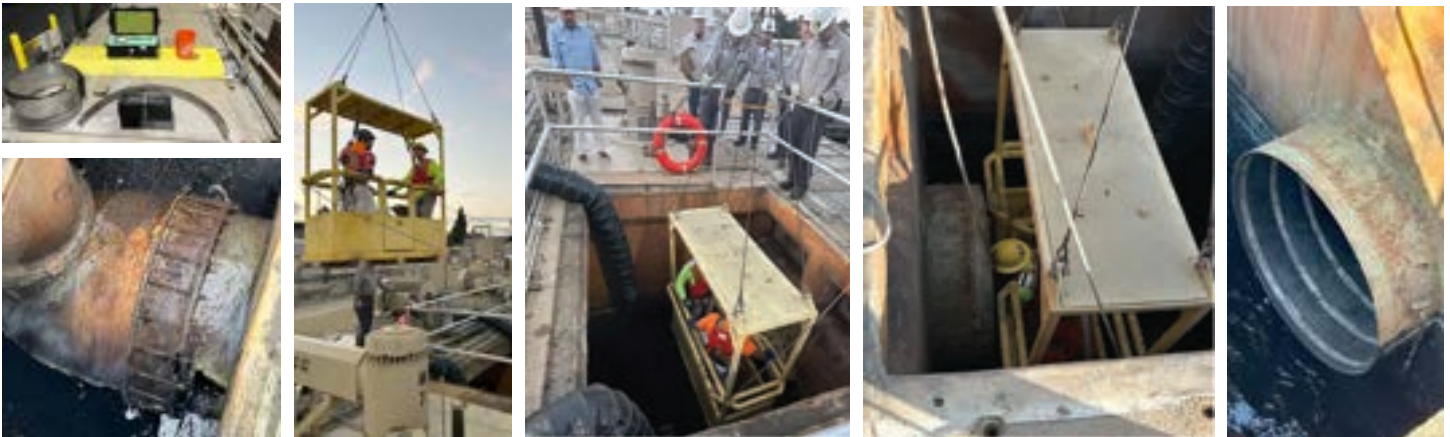
A double-wide seal with an 18" stainless steel backing plate was chosen for the repair due to the minimal surface preparation needed, the quick installation, and how easily the seal could be tested for quality control purposes.

The sanitary line was shut down at 5:00 a.m. and installation began at 6:00 a.m. First, the epoxy lining had to be removed. After a uniform surface was achieved, the backing plate was positioned to cover the hole. Finally, the seal was locked in place so that the rubber ribs were positioned on either side of the backing plate. The installation was completed at 10:00 a.m.
