# HydraTite®

JOINT SEAL

A municipal water utility in Central Arkansas discovered a failing joint in a 43.25-inch diameter metal pipe with a concrete liner. The joint, previously welded, had separated under operational pressure, causing exfiltration and pressure loss. The leak risked further pipeline degradation, necessitating an immediate, durable repair without costly excavation or replacement.

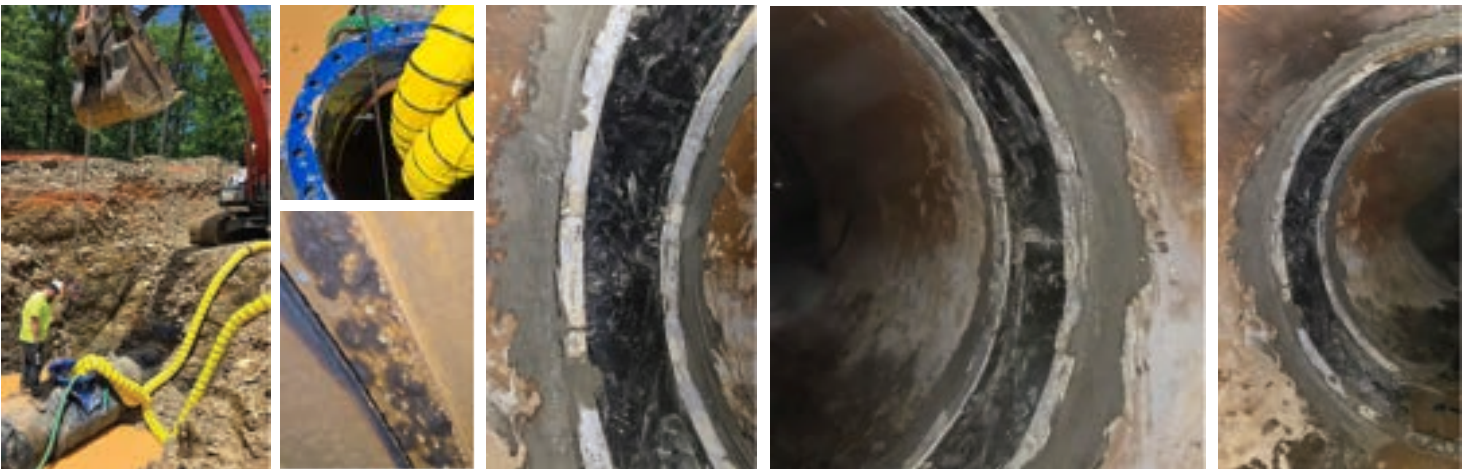
The project required sealing one compromised joint in a 43.25-inch water main. After ventilation was established, two HydraTech technicians were lowered into the pipe via a winch connected to an excavator. They chipped away the concrete liner to expose the metal pipe, cleaned the surface, and installed the HydraTite seal by positioning the rubber over the joint, securing it with retaining bands, and locking them in place. An air test verified the seal's integrity, and concrete was applied to restore the liner. The repair took three hours, and once the concrete hardened, the pipe resumed service, maintaining pressure.
