# HYDRAWRAP

STRUCTURAL COMPOSITE REPAIR SYSTEM

## Challenge

The challenge was to reinforce defected areas of a high pressure gas transmission line due to external corrosion and provide protection from further corrosion.

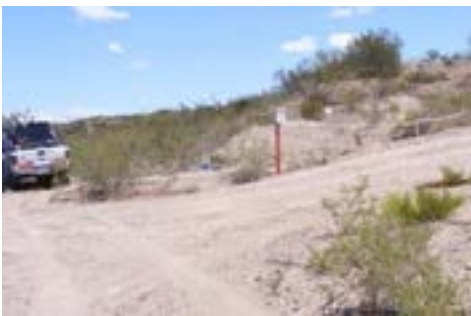
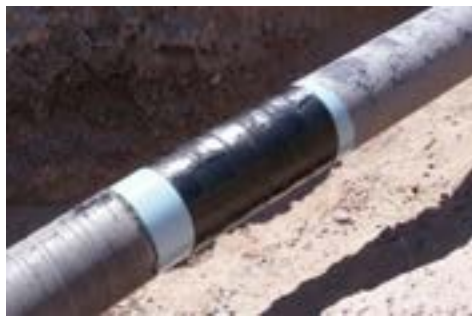
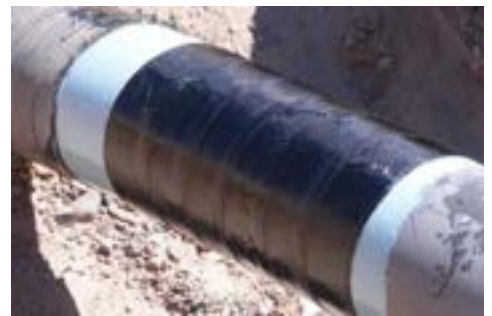
The solution utilized four layers of the HydraWrap® carbon fiber system to repair areas of the pipe with wall losses of 40% or greater. The exterior of the piping was prepared by grit blasting the surface to remove any dirt and loose debris and to obtain a surface profile. Once the surface was prepared, the HydraWrap® epoxy primer was applied to fill in voids to bring the pipe back to original shape and promote adhesion. Once the pipe's surface was primed, the HydraWrap® carbon fiber was saturated with HydraWrap® wet-out epoxy and applied to the primed surface.

Two separate areas of the 14-in pipe were repaired and reinforced with the HydraWrap® carbon fiber reinforced composite. The HydraWrap® system restored the structural integrity and extended the service life of the pipe.
