## Market

Culvert rehabilitation

# Challenge

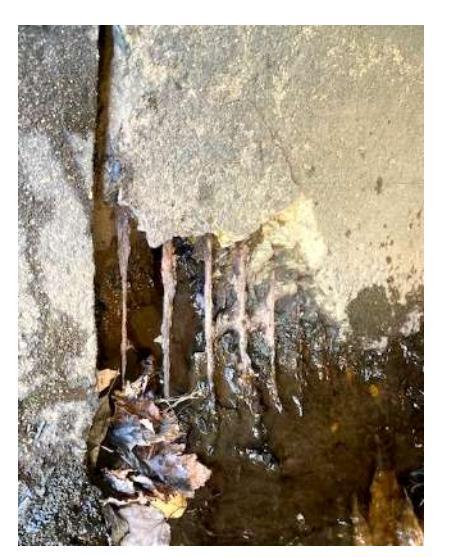
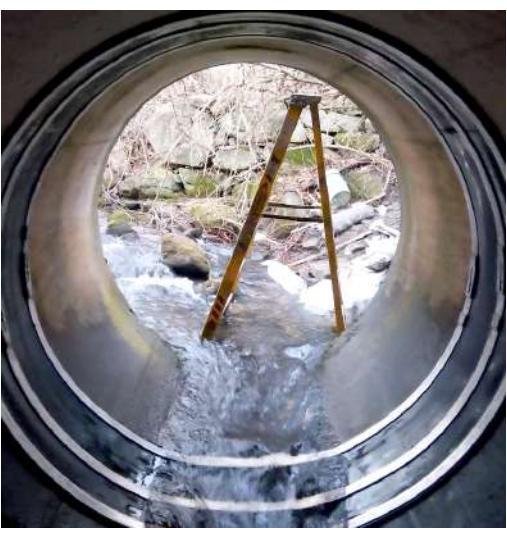
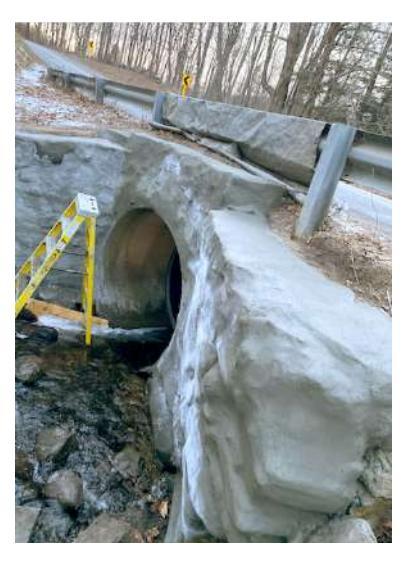
A culvert in Watertown, CT had a significant water flow and erosion problem which led to culvert joint separation, invert deterioration, erosion issues, and headwall damage. The erosion had undermined the outlet which resulted in a disruption in water flow. With the age of the culvert, the inlet headwall was made with stacked stone. Over time these stone headwalls can settle and become weak and start to lose structure. This culvert was located under a roadway which also has challenges with traffic control. The separating joints caused concerns with the above roadway being damaged by infiltration.

Hydratech implemented an engineered solution to address all of these issues. HydraTite Seals were installed over the culvert joints for a permanent solution to the separated joints that were leaking and eroding the ground below the roadway. 5 tons of riprap (large diameter stone) was placed over the existing outlet void to prevent further deterioration and erosion by restoring natural water flow. The stone headwall was encased in two layers of concrete to prevent further structural damage and environmental erosion.

The job consisted of the installation of 9 HydraTite Seals that were 72" in diameter, placement of 5 tons of riprap, concrete patching inside the pipe, the concrete casing of inlet stone headwall.

The HydraTite Solution enables a trenchless repair at a fraction of the cost of fully lining the pipeline. The sealed joints and repaired invert will restore the hydraulics and eliminate damage to the above roadway by preventing infiltration. All of this work was completed from the side of the road impeding traffic minimally. The HydraTite seal proved to be an economical in situ repair solution.
