BETTER MOUSETRAPS:
SEMI-STRUCTURAL COATING
FOR CULVERT REPAIR
PAGE 36

QUICK FIX

A semi-structural polyurea coating helps an Ohio city repair a culvert in a high-traffic business district without disruptive excavation

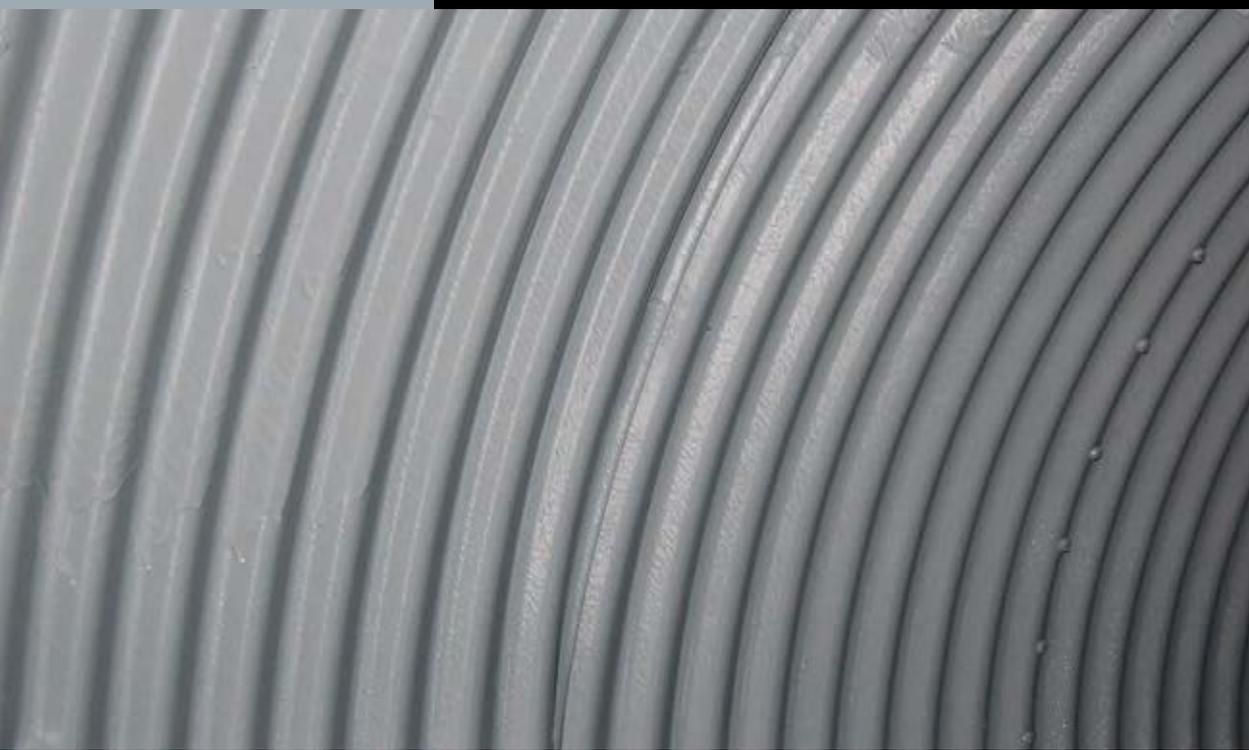
PolySpray SS-100 polyurea lines the inside of the rehabilitated culvert, providing excellent corrosion and abrasion resistance. (Photos courtesy of HydraTech Engineered Products)

The PolySpray product was applied with Graco heated plural component spraying equipment at 9-mm thick from the 4 o'clock to 8 o'clock position, and 5-mm thick for the remaining surfaces.

The coating created a sound repair without reducing the pipe's hydraulic capacity and without any excavation. The material is a rapid-setting, semi-structural polyurea monolithic coating that provides moderate structural support to the host structure and resists incidental chemical exposure. It is designed for 30- to 120-inch pipes and can be applied in thicknesses from 0.25 inch to greater than 2 inches in a single pass.

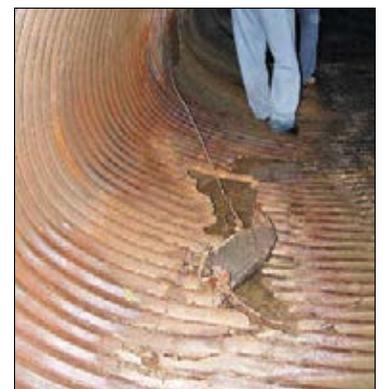
The 347-foot-long, 112- by 75-inch corrugated metal culvert on State Route 48, next to the Interstate 70 intersection, was deteriorating at the invert. Its galvanized metal bottom had eroded and corroded significantly.

Initial inspection of the culvert revealed severe corrosion and structural failure.

To complete the repair, the contractor first bypassed the water flow through the culvert using a 4-inch automated pump system. Bypassing ran continuously for the duration of the job. Workers then removed the original tar lining from the culvert with a 40,000 psi waterjet.

The pipe bottom proved to be in unusable shape from groundwater damage, so the team decided to re-establish the entire invert by completely re-patching it. They prepared all surfaces using a garnet abrasive.

Next, workers repaired the corroded and damaged invert using welded wire concrete reinforcing mesh attached to the base material from the 5 o'clock to the 7 o'clock position. They poured Class C concrete over the entire length of the culvert, three to four inches thick.

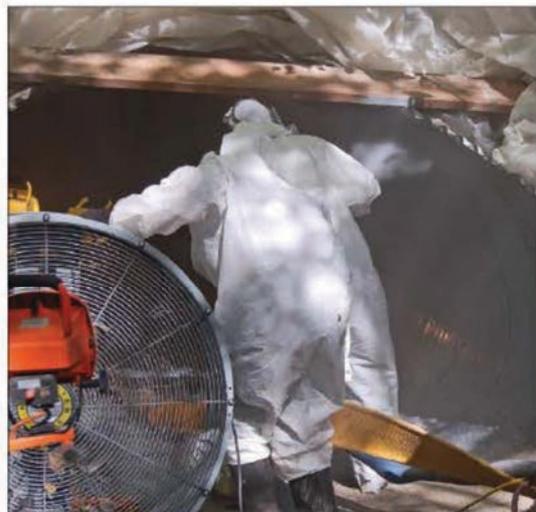
Proper personal protective equipment is vital to employee safety during PolySpray application.
