HydraWrap® (Fiber Reinforced Polymer)

Water Treatment Plant

HYDRAWRAP
STRUCTURAL COMPOSITE REPAIR SYSTEM

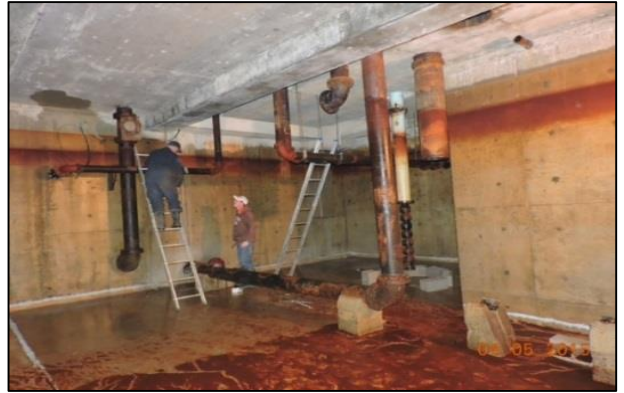
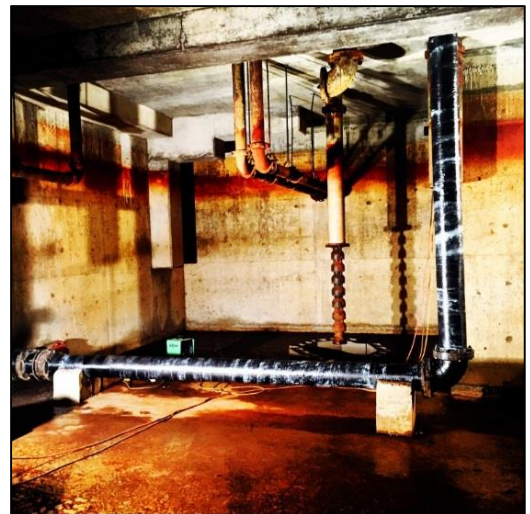
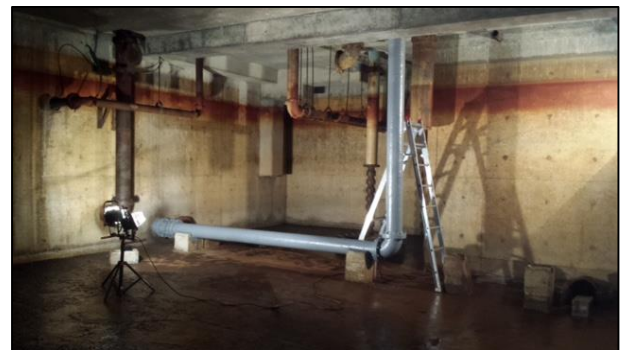
A section of piping that is immersed in a treatment tank had several deteriorated areas that required repair.

The HydraWrap composite repair was designed to reinforce an 8" diameter carbon steel supply pipe with a maximum design pressure of 90 psi. The design of the HydraWrap was based on limiting the strain in the composite repair to the allowable strains recommended by ASME. After applying the HydraWrap system to the pipe, the composite repair was top coated with HydraTech's NSF61 8001 Waterline epoxy. The project took less than a week to perform.
