HydraWrap® (Fiber Reinforced Polymer)

Power Generation

The challenge was to repair cooling water piping corrosion.

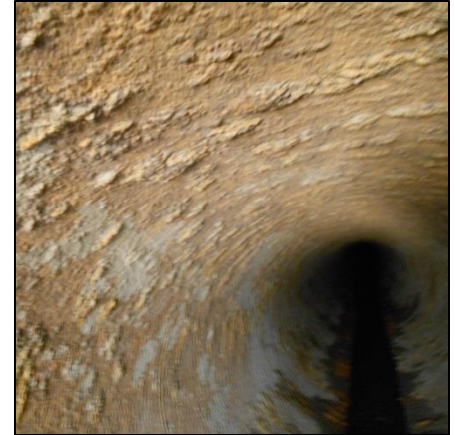
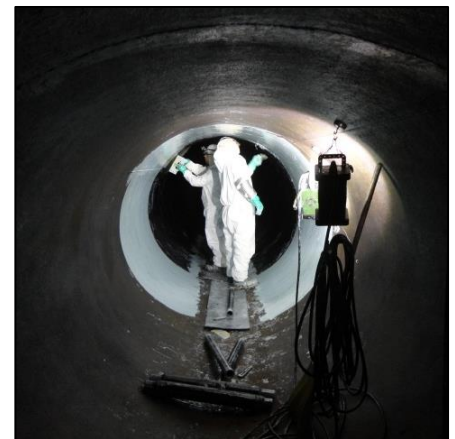
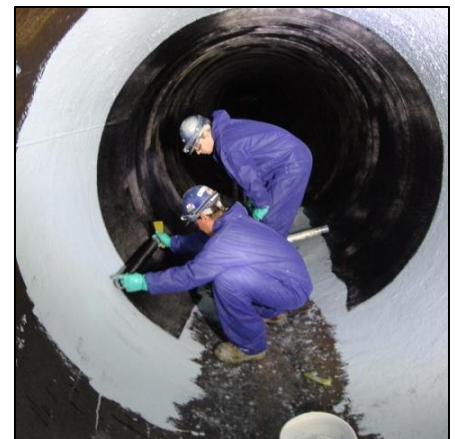
The cooling water pipe system consisted of approximately 1,500 feet of 72-in carbon steel piping. The system supplies cooling water to vital components in the power plant.

Inspections conducted on the cooling water pipe revealed signs of corrosion with certain areas having a significant amount of wall loss. Rehabilitation was required to prevent further corrosion and add structural reinforcement to the host pipe.

The client specified a carbon fiber composite system and selected HydraWrap for its corrosion resistant and structural properties, coupled with its economical pricing. The terminations of the HydraWrap carbon fiber lining were sealed with HydraTech's HydraTite® internal pipe seals. The installation involved proper surface preparation by high pressure water and abrasive blasting. The project was successfully completed during the scheduled outage at a fraction of the time and cost it would have taken for direct replacement.
