PolySpray

A large coal fired power plant in Pennsylvania required repair to a steel bypass piping that redirected cooling water from the cooling cells directly to the basin. The project to rehabilitate the piping was urgent and only a five day work window could be accommodated within the start-up schedule.

POLYSPRAY
POLYUREA BASED LININGS

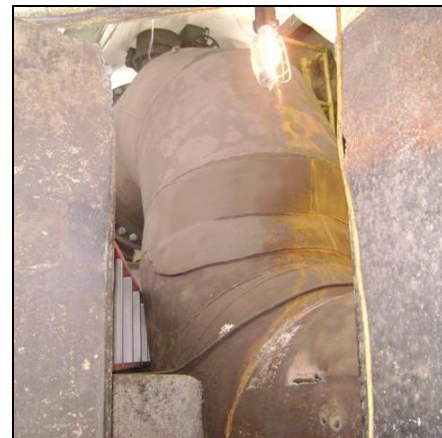
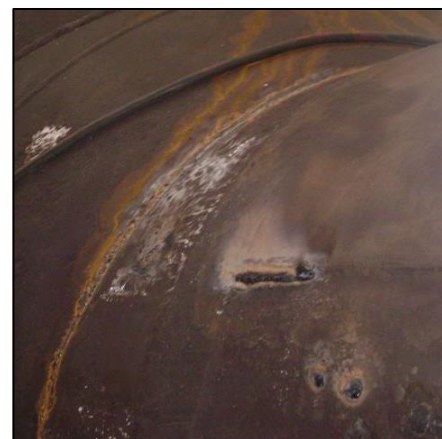
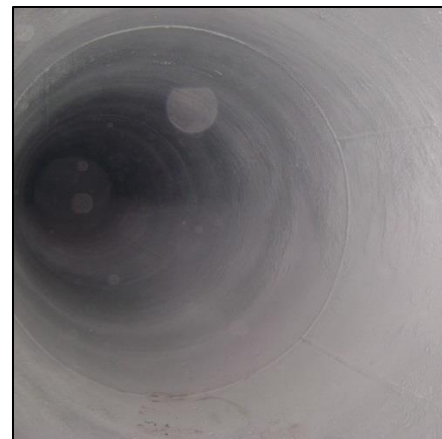
The line consisted of 42-ft of 42-in diameter carbon steel piping that had severe erosion and corrosion. Particular concerns to the client included two 90 degree elbows situated within the piping that had severe wall loss and required immediate attention.

To reduce installation time the piping was grit blasted to SSPC 6/NACE 3 commercial blast parameters, surface profile to 3-4 mils. To maintain the 75 psig rating of the system, engineering calculations specified a thickness of greater than 3-mm to line and prevent leakage within the system. Any through wall holes greater than .25-in per weld, were welded.

A HydraTech manufactured epoxy filler (HydraLine) was used to address severe pitting on the internal radius of the lower 90 degree bend of the pipe fitting. The butterfly valve was masked off to prevent overspray and debris from accumulating on the valve disk and seat. The process took less than a day to complete. The following day the pipe went back in service without any leaks and its operational life was extended.
