PolySpray

The challenge was to rehabilitate a severely deteriorated twin 60-in corrugated metal storm culvert that was failing.

PolySpray FS-250, used at a thickness of 0.8-in for structural repair, was proposed as the solution to eliminate ground settling.

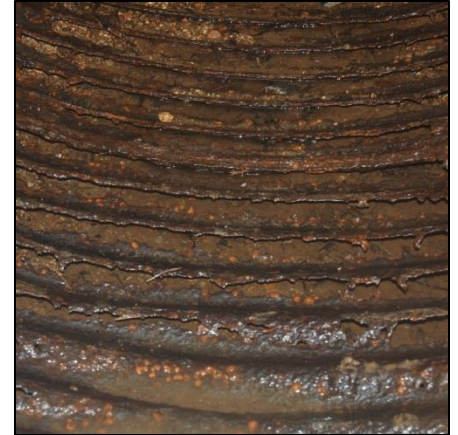
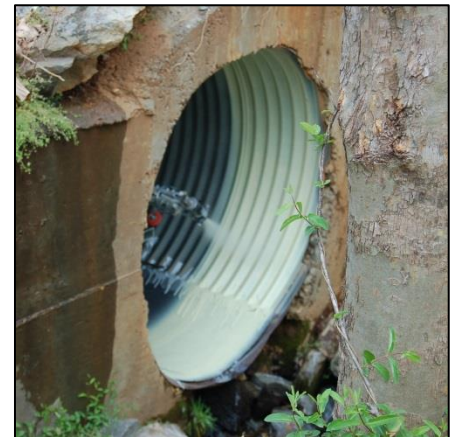
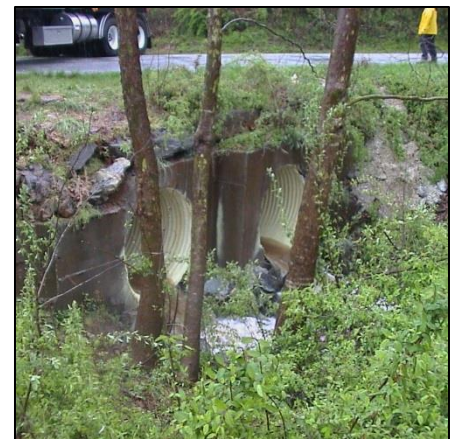
One side of the corrugated metal culvert was isolated and the flow directed through the other. After cleaning, the inspection revealed that the bottom of the culvert was completely deteriorated. The bottom was stabilized with concrete to fill voids and provide a form for the PolySpray. Each side was independently spray applied with PolySpray FS-250, with each application taking one day to complete.

The PolySpray lining solution extended the life of the culverts by rebuilding the eroded invert and stabilizing the soil around the pipe. The lining not only added structural strength, it eliminated further corrosion/erosion to the steel culvert.
