Market

Transportation

A corrugated metal pipe had joints that were starting to separate under interstate I-71. A solution was needed that would affect traffic minimally.

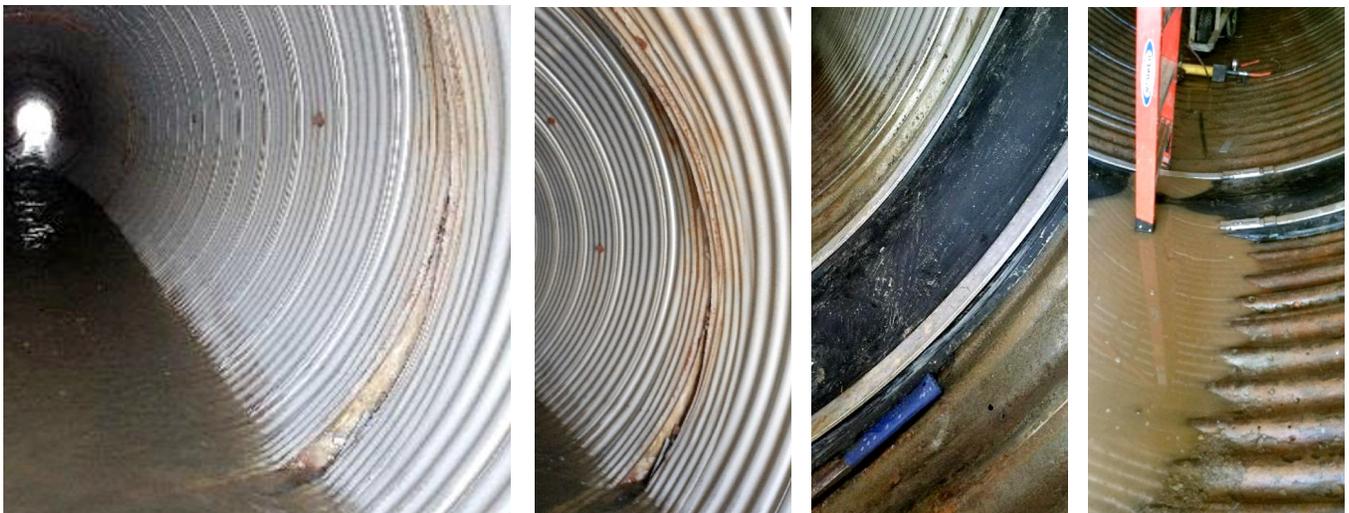
Four joints on the 10.5'-diameter corrugated metal pipe required sealing to stop leaks and prevent further separation. Separated pipe sections were offset by as much as 5". The corrugated metal valleys were filled with additional rubber behind the ribbed sections of each seal. Double-wide seals, which have a joint span of 16" were used for maximum flexibility. The seals were installed in 3 days.

The proposed solution utilized customized HydraTite Internal Joint Seals. The degree of separation required double-wide HydraTite seals.

The project was completed at a fraction of the price and inconvenience of full replacement. The HydraTite seal will protect the above interstate from future sinkholes formed from leakage.
