Storm Water

An HOA in Florida was repeatedly experiencing sinkhole issues due to the inflow (I&I) of groundwater and soil at the pipe joints of a 53" X 34" reinforced concrete pipe (RCP) stormwater drainage system.

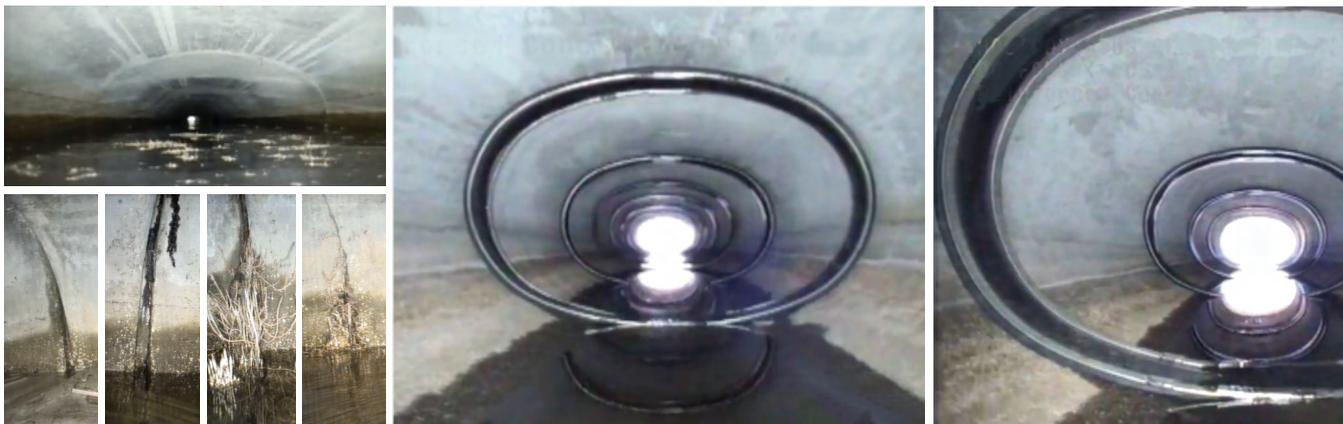
The project consisted of 22 pipe joints that required sealing. The sealing system withstood the head pressure developed by the high water table and the silty soil conditions.

The HOA reviewed several options for eliminating the I & I to prevent the development of sinkholes. These options included replacement of the entire pipe system, lining the pipe system, or sealing the joints. After evaluating lead times, cost, and job duration, the HydraTite Internal Pipe Joint Seal was selected.

The HydraTite seal eliminated I&I issues, and the system was approved and put into service. HydraTite proved to be a time-efficient, and cost-effective solution.
