INTERNAL PIPE

HydraTite®

JOINT SEAL

Market
DOT

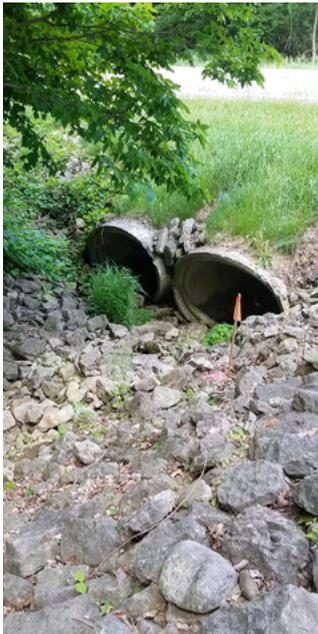
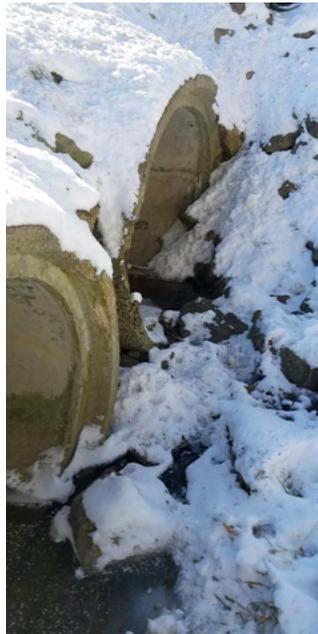
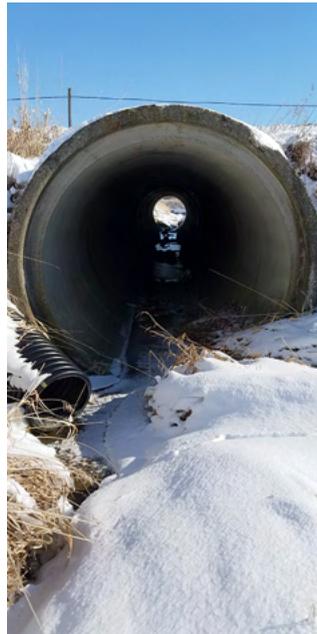
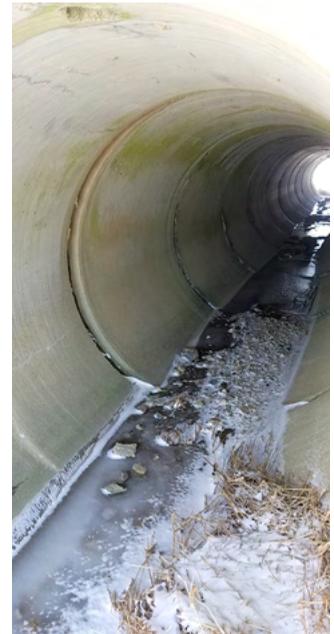
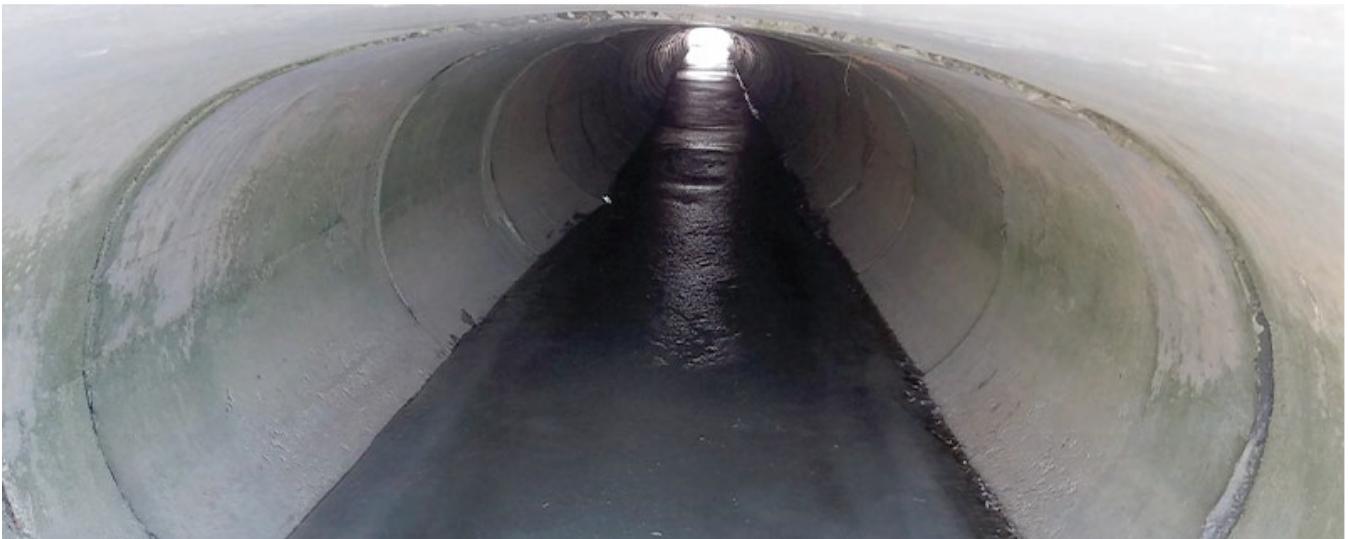
There were multiple sections of precast concrete culverts within ODOT District 7 that were showing signs of severe separation. The joint separation needed to be stopped so that the above roadways did not become damaged from infiltration/soil erosion.

The culvert joints needing repair were at the following locations: US 36 in Darke County, SR 287 in Logan County, SR 292 in Logan County, and two sections of interstate 71 in Shelby County. Extra-wide HydraTite seals were installed at these locations in the following sizes: six 60" diameter round, one 66" diameter round, eleven 48" by 76" elliptical, and two 43" by 68" elliptical.

Each pipe joint of concern was cleaned, smoothed with cement, and sealed with a HydraTite Internal Pipe Joint Seal. The installed HydraTite seals now prevent further separation of the existing pipe joints. This will help ensure infiltration does not cause soil loss under the existing roadways. The project was completed with minimal traffic disruption and at a fraction of the cost of other methods. This lifetime repair was successfully executed by HydraTech at 30 % below the engineer's estimate.
