Water & Utilities

This project consisted of installing (114) 72" HydraTite internal joint seals at all joints within the culvert under Interstate 90. The project also involved cleaning and removal of grout ports for prep work. The crew and all materials entered through the open ends with no disruption to the traffic as the seals were installed. Installation was accomplished in approximately three weeks during the summer of 2017.

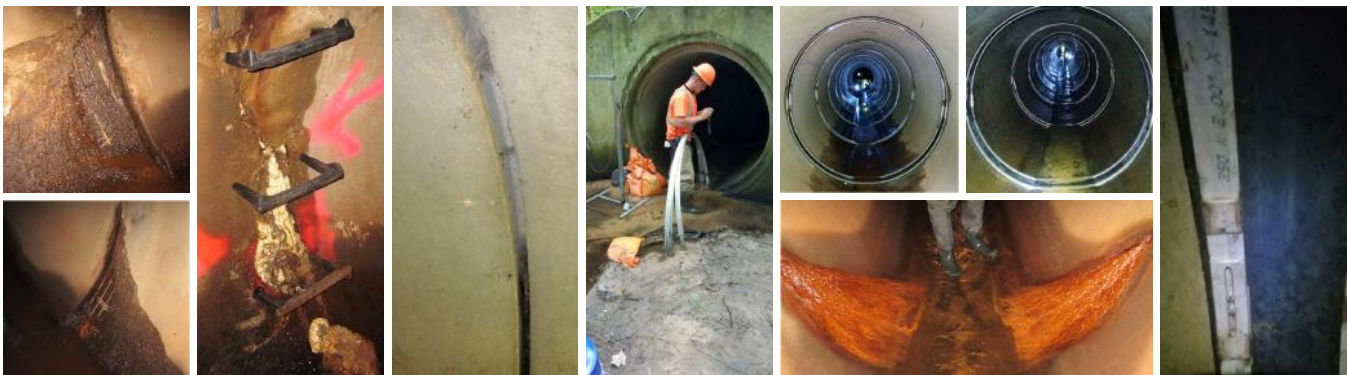
This trenchless repair was performed at a fraction of the price and inconvenience of full replacement. The finished product will prevent any further joint infiltration that would result in immense damage to the above interstate.
