HYDRAWRAP

STRUCTURAL COMPOSITE REPAIR SYSTEM

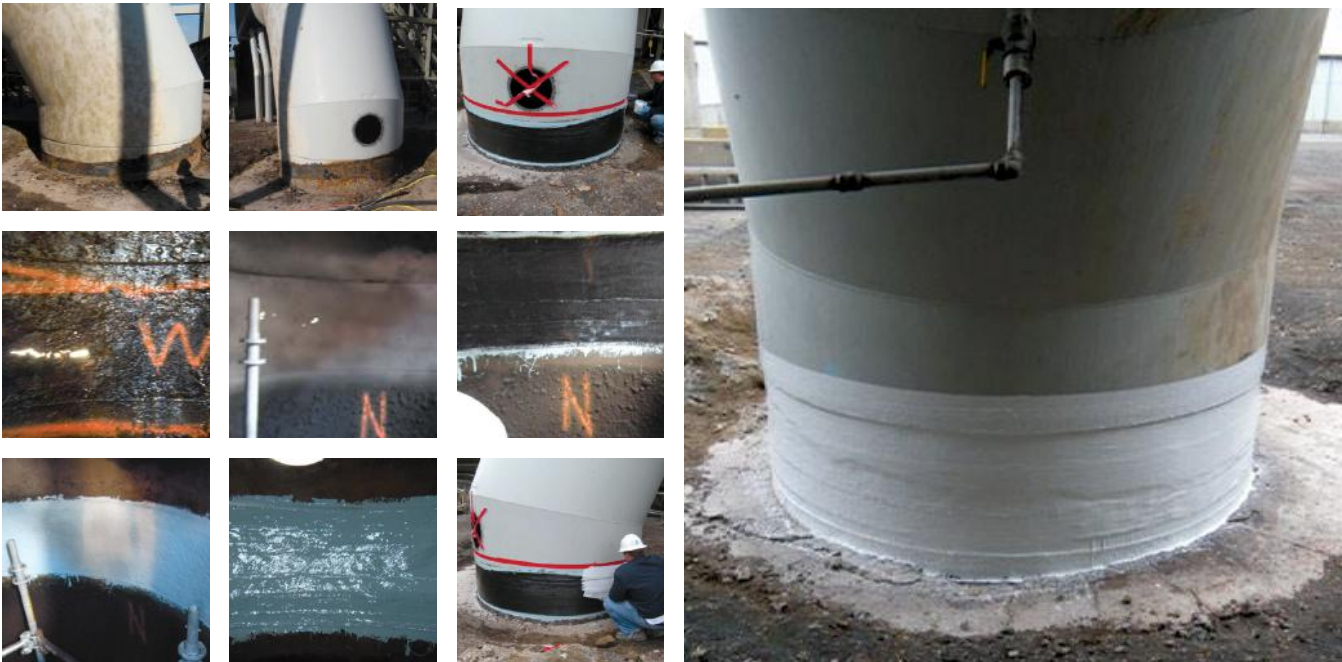
A 90" carbon steel pipe was suffering from severe corrosion damage at the soil-to-air interface in a cooling water system that was part of a power generation facility in Oklahoma. Some damaged portions were experiencing 100% wall loss. A structural solution was needed to seal the holes, stop corrosion and bring new life to the system.

The internal and external surfaces of the pipe were prepared and 7 layers of HydraWrap were applied to the inside of the pipe. Then 2 additional layers were applied to the exterior. Finally, the internal HydraWrap layers were coated in epoxy and the external layers of HydraWrap were coated with polyurethane to prevent damage from ultraviolet light.

This structural repair allowed for a more economic solution compared to replacement. HydraWrap provided this aging system with new strength and will prevent further corrosion.
