Market Storm Sewer

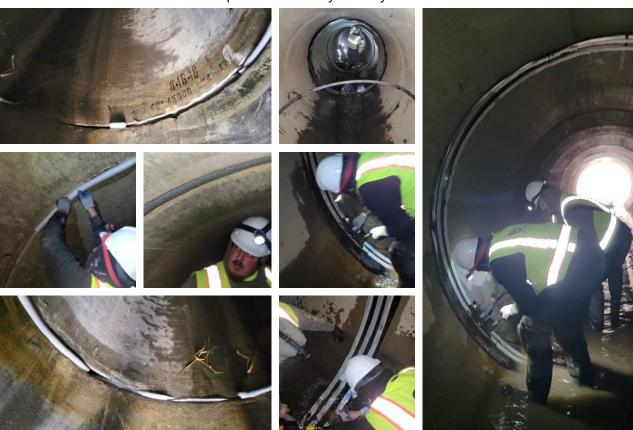
Pipe joints in a drainage pipe under a levee for flood control had become compromised. A Sealing solution was needed to control groundwater infiltration.

Seven joints raised concern in four pipes that were 48", 72", and 96" in diameter. Debris was cleared away from the joints, and the joints were then filled with foam filler. Finally, the seven standard-wide seals were then installed. The entire process took only two days.

HydraTite Internal Pipe Joint Seals were chosen to seal the joints as the pipes were structurally sound and repairing the joints would be more cost-effective than replacement. An additional interior retaining band was requested to ensure it would withstand up to 34 feet of external hydrostatic head.
