Drinking Water

Challenge

Engineered Solution

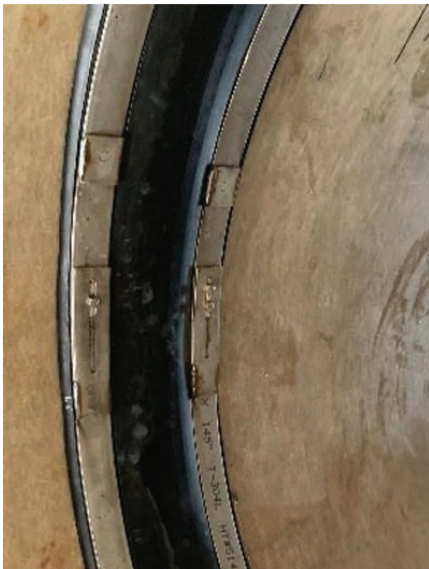
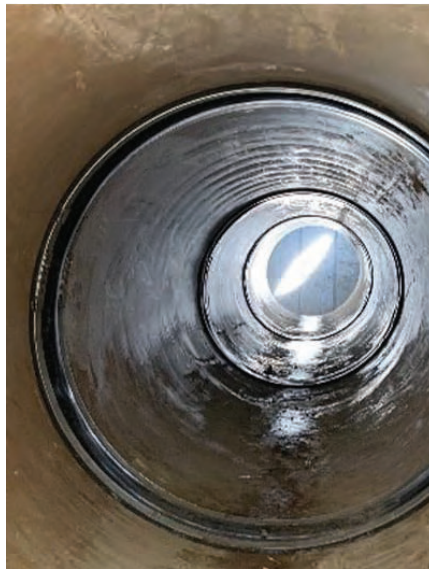
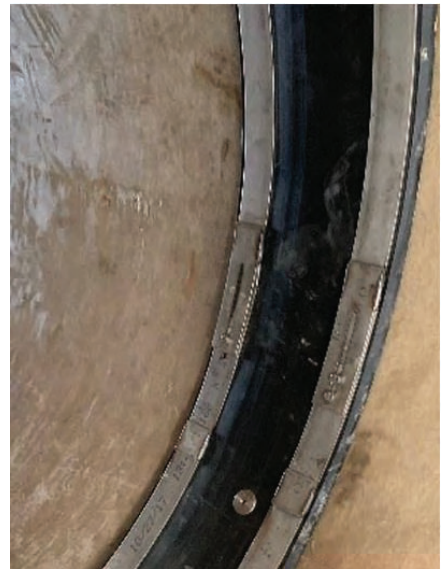
The client had discovered that their new piping was leaking at the joints. Three leaks were found to be the culprit.

One of the three sections of pipe made a 20-foot drop and was only accessible by narrow stairs. First, the surface of the pipe near the joints was prepped to ensure a smooth surface for installation. The rubber was then put in position and the stainless steel bands were expanded to lock the rubber in place.

HydraTech provided three HydraTite Internal Pipe Joint Seals manufactured with a 54" diameter.

HydraTite provided a solution quickly and was a more cost-effective solution compared to replacement. The system's joints were reinforced and service life was prolonged.
