INTERNAL PIPE

HydraTite®

JOINT SEAL

Market
DOT

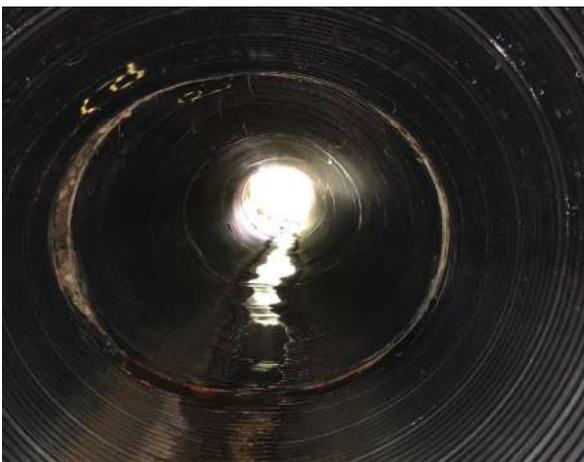
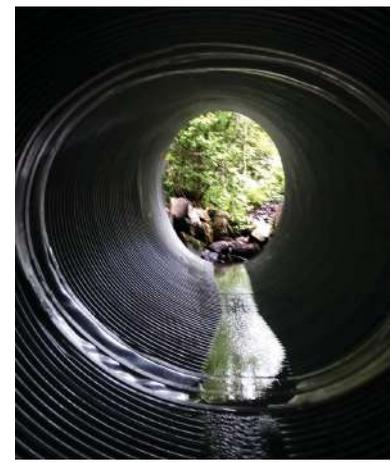
A culvert in New Vineyard, ME had a significant infiltration problem at two pipe joints which led to culvert joint separation, erosion issues, and pavement settlement. The infiltration at the joints had caused the backfill around the pipe to create a void around the joint and cause the pavement to settle. The corrugated metal culvert had been replaced 15 years ago, however, it was improperly backfilled and the joints were not watertight. Over time the infiltration caused the pipe to settle as well as the backfill to infiltrate into the pipe.

The job consisted of the installation of 2 HydraTite Seals that were 108" in diameter to eliminate infiltration as the two joints that had failed. The surface was filled with rubber to provide a smooth surface for a watertight seal solution.

HydraTite enables a trenchless repair at a fraction of the cost of fully lining the pipeline or excavation. The sealed joints eliminated infiltration and stopped the settlement of the pavement. The job was done quickly and without disruption to traffic. HydraTite is a solution not only for failing concrete joints but corrugated metal drainage pipes as well.
