Market
Power

Excessive water was entering through pipe joints and required constant water pumping at a Generating Station in Pennsylvania.

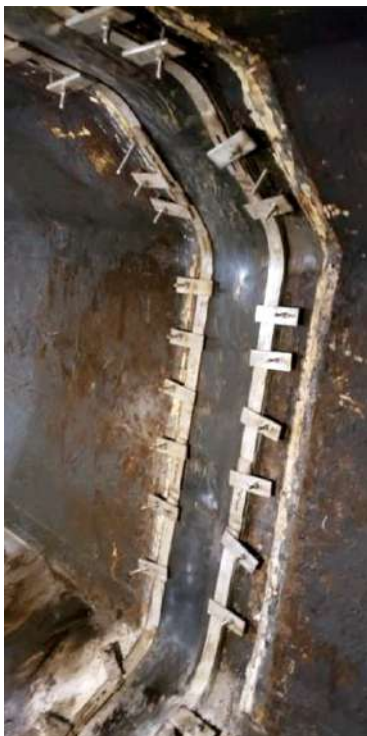
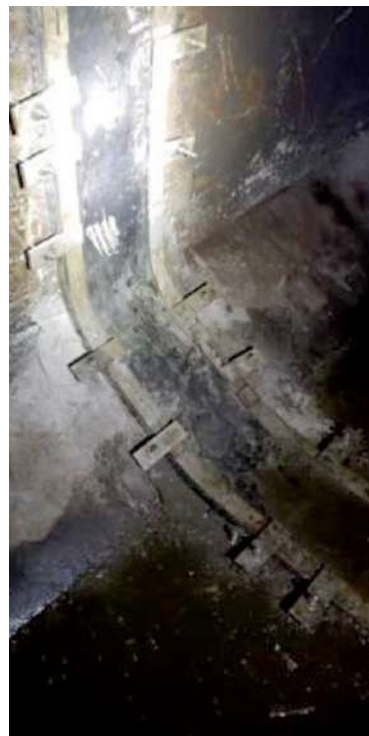
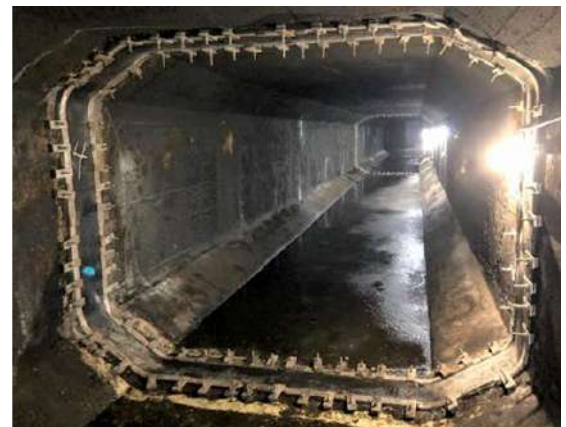
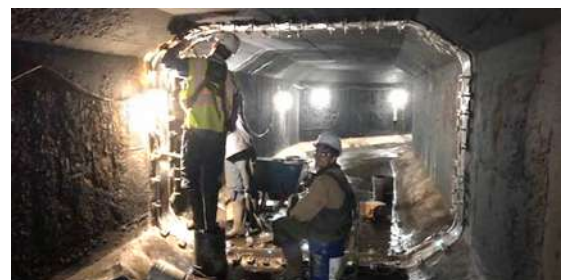
After cleaning and prepping, each joint location was repaired with a HydraTite Box Seal. Eight joints were repaired with box seals; four on the cold-water side and four on the hot-water side.

The proposed solution utilized the custom HydraTite Box Internal Joint Seal. This is a custom-manufactured seal frequently used to repair defective joints in box culverts, tunnels, and conduits with rectangular or non-circular cross-sections. It is also suitable for gravity and pressure applications.

The project was completed at a fraction of the time and cost it would have taken for pipe replacement.
