# INTERNAL PIPE HydraTite® JOINT SEAL

A New York water utility discovered a leak in a 24-inch ductile iron drinking water pipe running between a pumphouse and an elevated water tower. The pipe was located in a confined section of the system, making excavation and replacement costly and disruptive. The utility needed a potable water–approved repair solution that could eliminate leakage internally and extend the life of the pipe without service interruption.

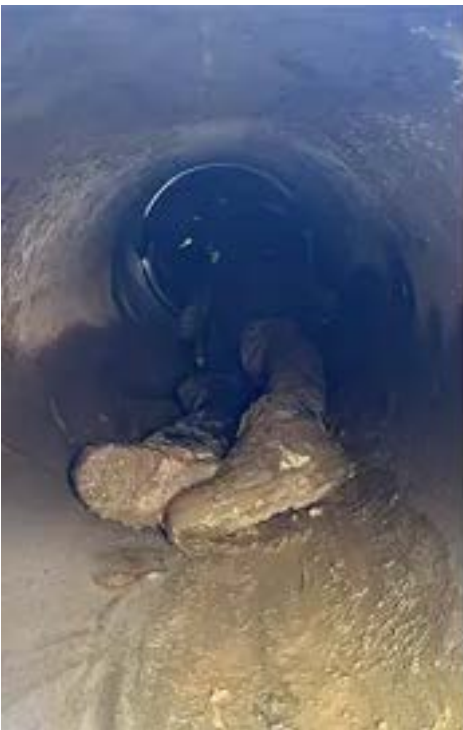
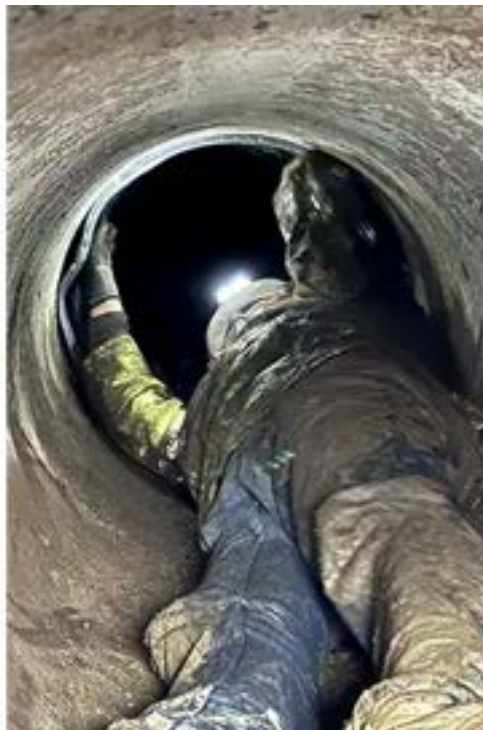
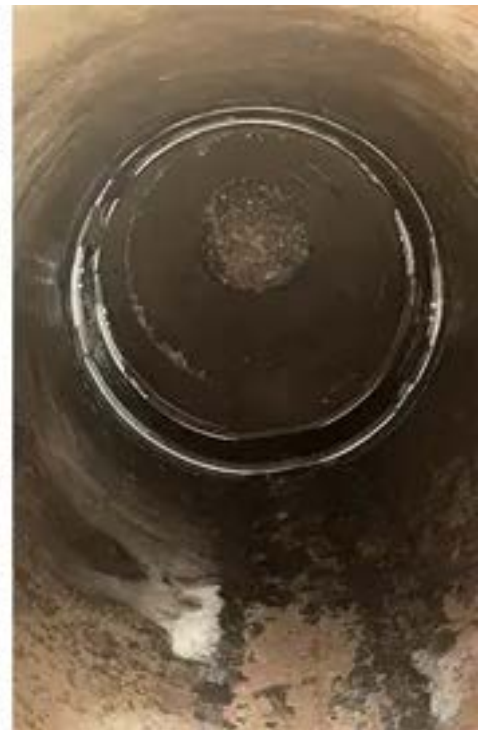
The prime contractor provided access to the pipe by cutting an opening near the leak site. HydraTech's two-person crew took turns working in the 24-inch line to install a HydraTite® seal at the leaking joint. Once inside, the crew observed that the adjacent joint had become offset, prompting a second seal installation. The pipe's internal liner was carefully chipped away near each joint to ensure continuous rubber contact around the pipe's interior circumference.

Each seal was positioned over the joint, and two-piece stainless steel retaining bands were tightened on either side, locking the rubber in place. Because this was a potable water application, both seals were air-tested using the integrated test valve: air was pumped behind the rubber, a soapy water solution was applied around the edges, and the absence of bubbles confirmed a tight seal.

The crew successfully installed and tested both HydraTite® seals in one day within the confined space.
