# INTERNAL PIPE HydraTite® JOINT SEAL

**Market**  
*DOT*

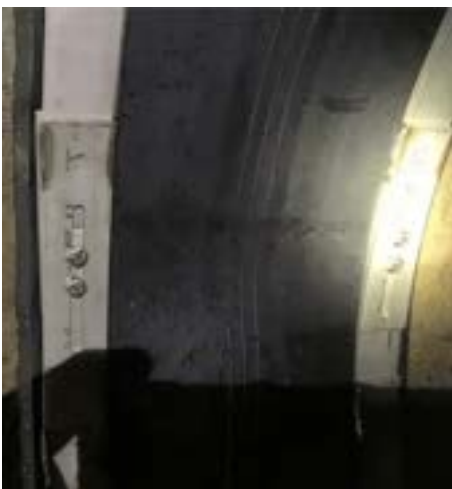
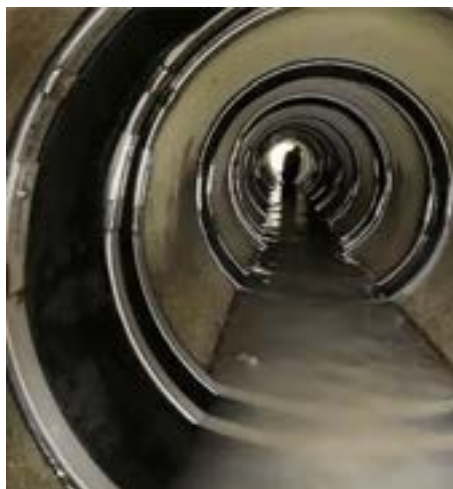
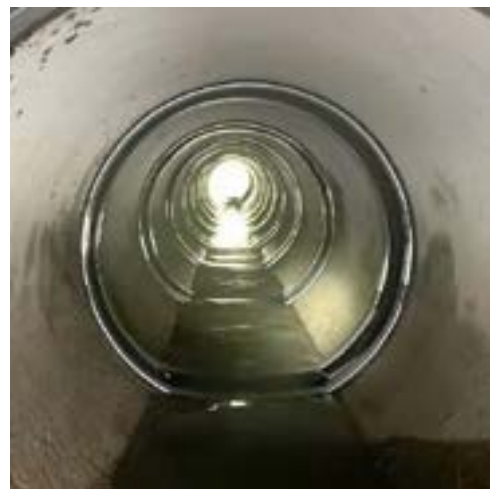
13 culvert joints had become separated under a state route. This could eventually become a safety concern for the roadway above. A solution was needed that could be installed quickly without detrimentally affecting the traveling public. There were no plans to dewater the culvert and so the solution need to be installed despite the water.

The HydraTite Internal Pipe Joint Seal was selected as the rehabilitation technology. Depending on how far the joints had separated, various widths had to be used. This HydraTite seal can be installed in partial flow and so the pipe did not need to be dewatered for the repair.

The entire process was completed in two days. First, the pipe surface needed to be inspected and cleaned. Lanes were temporarily closed, and then seals were installed mechanically using a hydraulic expander.
