# INTERNAL PIPE HydraTite® JOINT SEAL

A corrugated metal pipe had joints that were starting to separate under interstate I-71. A solution was needed that would affect traffic minimally.

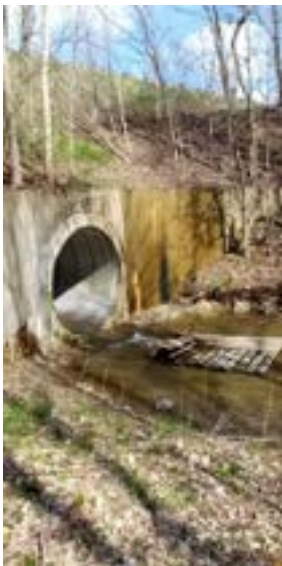
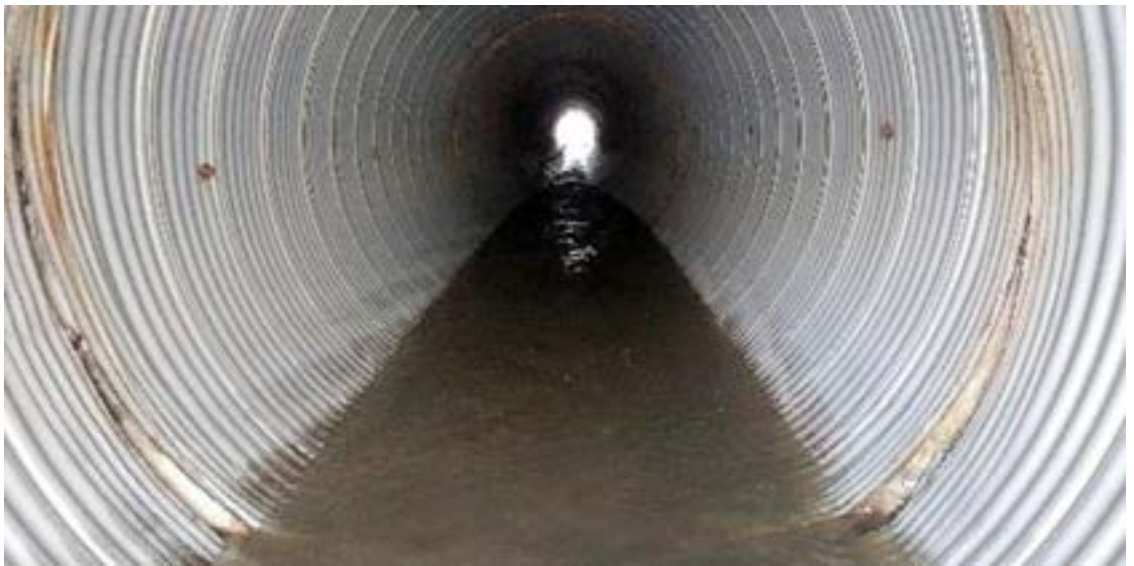
Four joints on the 10.5'-diameter corrugated metal pipe required sealing to stop leaks and prevent further separation. Separated pipe sections were offset by as much as 5". The corrugated metal valleys were filled with additional rubber behind the ribbed sections of each seal. Double-wide seals, which have a joint span of 16" were used for maximum flexibility. The seals were installed in 3 days.

The proposed solution utilized customized HydraTite Internal Joint Seals. The degree of separation required double-wide HydraTite seals.
