# HydraTite®

JOINT SEAL

## Market

*Wastewater*

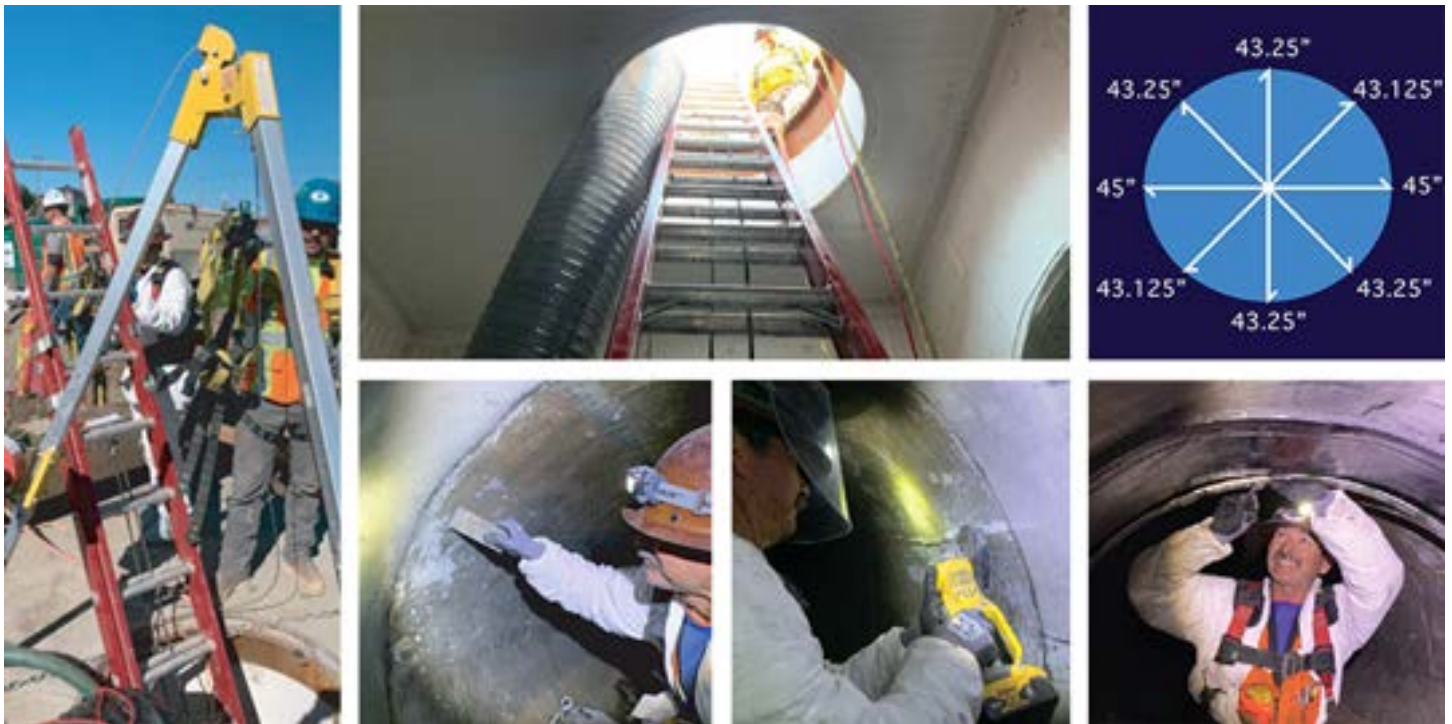
A pressurized sanitary line that was approximately 45" in diameter had been repaired with CIPP (cured in place liner), but water had started to backtrack behind the liner. Replacement would be time-consuming and expensive, and coating or grouting behind it would not provide for a long-term repair.
