INTERNAL PIPE

# HydraTite®

JOINT SEAL

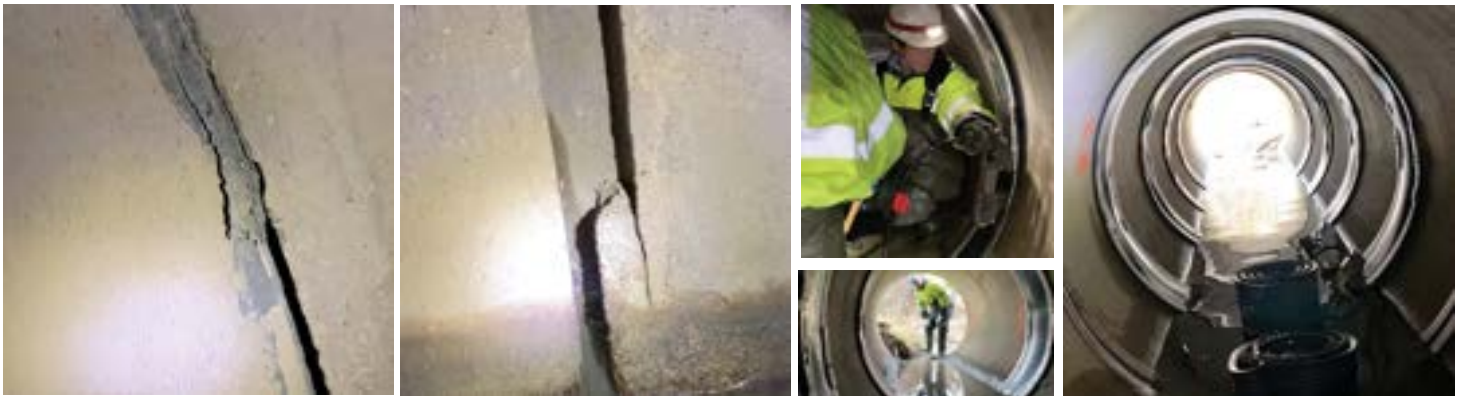
Rocks and soil had become exposed at the culvert's separating joints and the quickly falling temperature pressed the project's time frame. The project needed to be completed as soon as possible. Previous repair methods that utilized sealant and grout were now failing. Infiltration, erosion, and eventual sinkholes were a concern as they could stop the above traffic.

HydraTite of various widths 11"-21" were installed. Stainless steel backing plates were installed beneath the EPDM seal where the joint's separation was more severe.

The project was scheduled to take 3 days but was completed in only 2 days. HydraTech had to grind and clean the concrete surface of the culvert to ensure the 31 seals were installed properly, many with backing plates. The entire project was completed despite the low temperature and standing water.

The HydraTite seal provides an economical repair to prevent infiltration and erosion without the need for dewatering or digging. The project did not affect the above traffic and ensured that the traveling public would be safe from future sinkholes. The quick turnkey solution was implemented before the freeze and thaw of the coming months exacerbated the pipe joint degradation. The HydraTite seal does not rely on adhesive or sealant and is not adversely affected by temperatures.
