# HydraTite®

## Market

*Power*

## Challenge

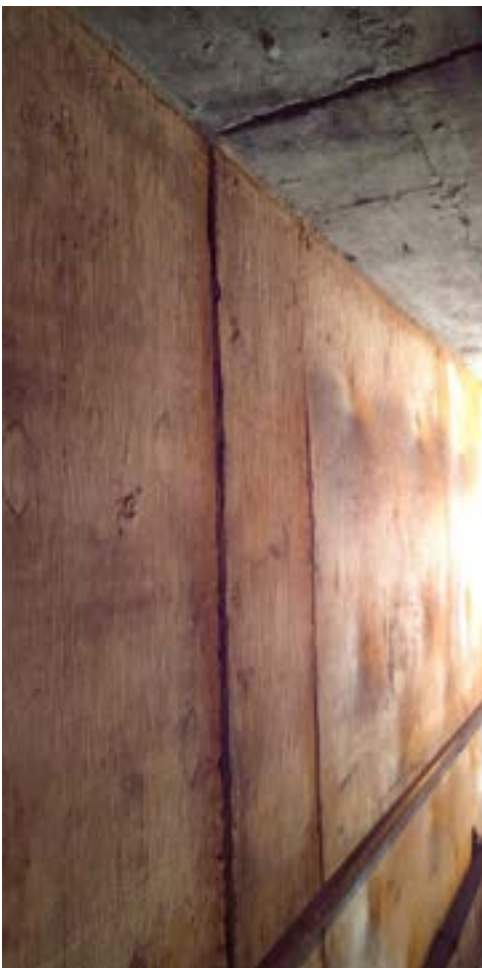
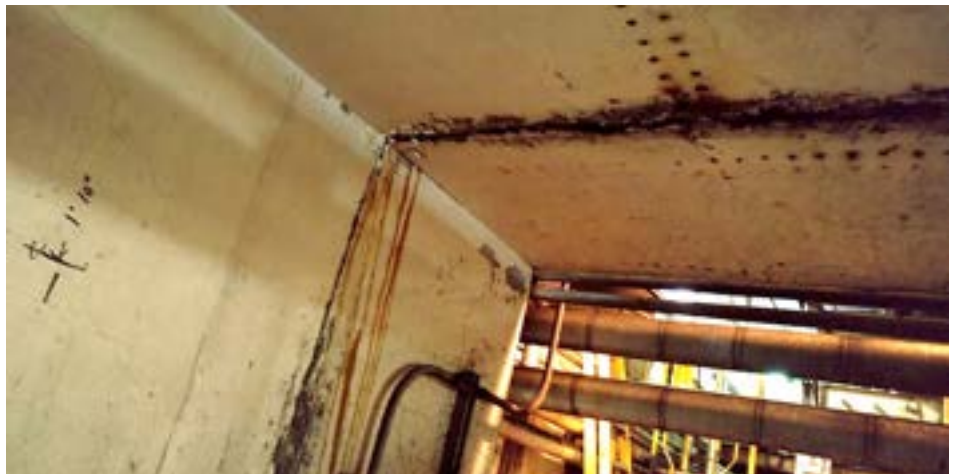
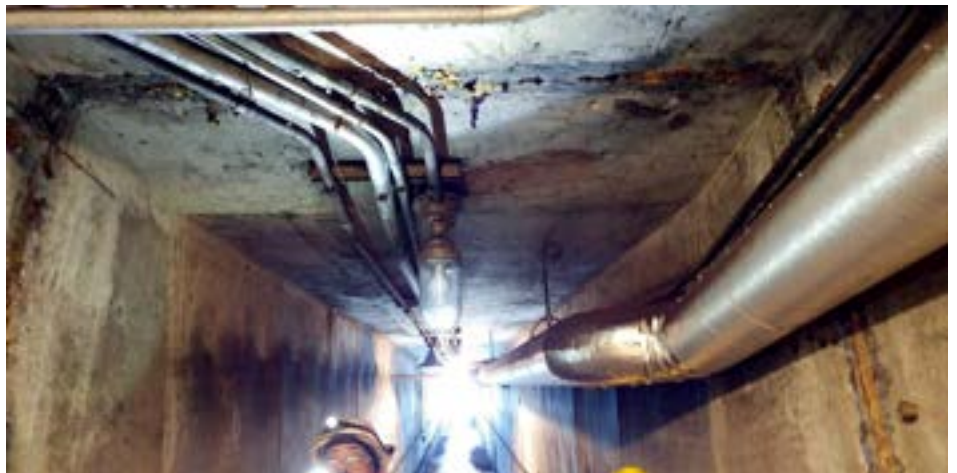
Groundwater was infiltrating a coal conveyor tunnel. The infiltration was at the joint of a concrete foundation in the tunnel. Damage from the water infiltration inside the tunnel was evident in the uneven settling of concrete sections. The water inside the tunnel also could damage equipment and was a slipping hazard for workers.

To eliminate the infiltration of water into the tunnel the HydraTite Box seal was proposed as a solution. The HydraTite Box seal is a customized mechanical remediation with no excavation required. The HydraTite Box seal flexibility accommodates ground settling and expansion/contraction. The seal's superior quality and intricate design assure a tight and leak-free seal.

Surface prep included moving conduits, relocating beams for the conveyor system, and removing grout ports. The existing joint surface had to be chipped and scraped to create a clean surface for a watertight install. Due to the slope of the tunnel, concrete corners were used instead of steel forms to allow the HydraTite seal to accommodate the 90-degree corners. The straight sections of the HydraTite seal are equipped with anchor clips.
