# HydraTite®

JOINT SEAL

## Challenge

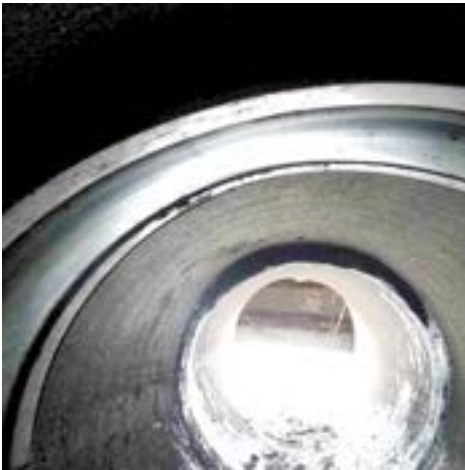
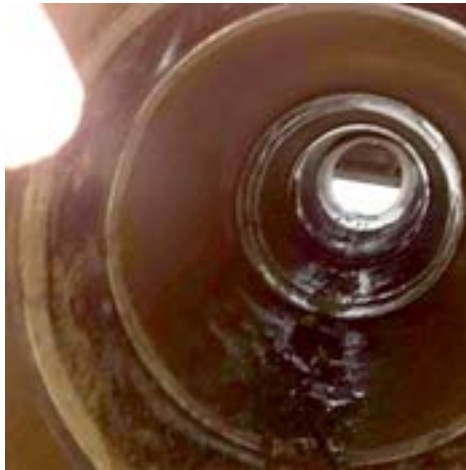
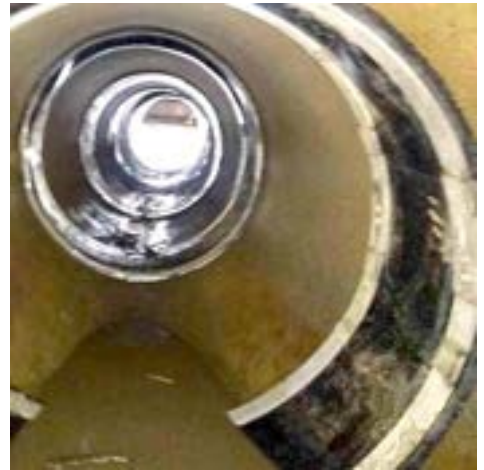
Five joints had become compromised in a 36" reinforced concrete pipe and were leaking. All the joints were somewhat offset, but three had severe offset. Two joints had offsets of 2" and one joint had an offset of just over 2".

After pipes were dewatered, the joints were cleaned and any deteriorated adjacent pipe surface was repaired to provide a uniform surface profile. The joints were sealed with extra-wide 36" diameter HydraTite Internal Pipe Joint Seal. The project was completed in only 8 hours.

These HydraTite seals provided a specialized repair that was able to accommodate the specific needs of each of the joints' unique complications. The leaks were sealed and the pipe returned to service after only a day of work. The HydraTite seal proved to be a fast and economical solution for the client.
