**HYDRAWRAP**  
STRUCTURAL COMPOSITE REPAIR SYSTEM

*Power Generation*

The challenge was to repair cooling water piping corrosion.

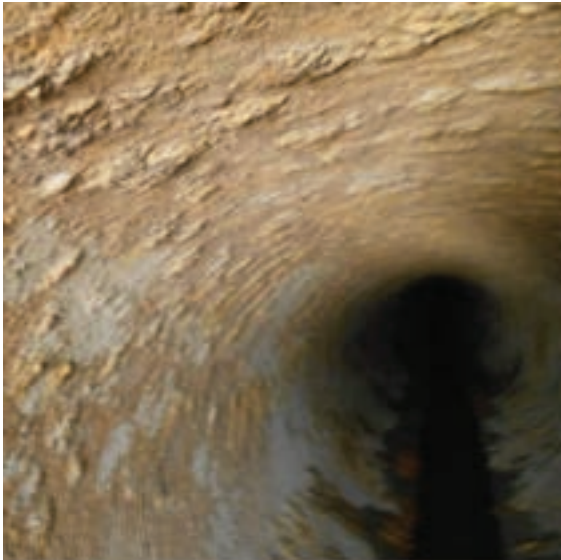
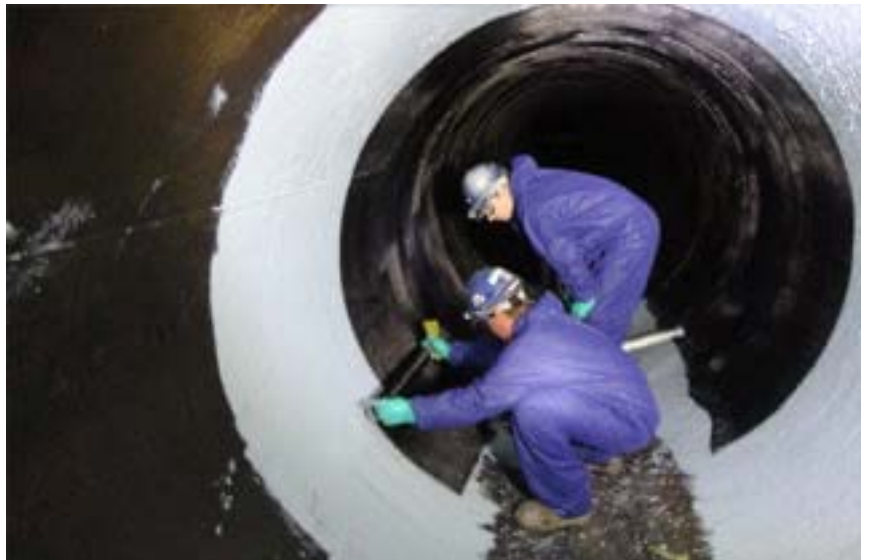
Inspections conducted on the cooling water pipe revealed signs of corrosion with a significant amount of wall loss in certain areas. Rehabilitation was required to prevent further corrosion and add structural reinforcement to the host pipe.
