# HydraTite®

JOINT SEAL

*Culvert Rehabilitation*

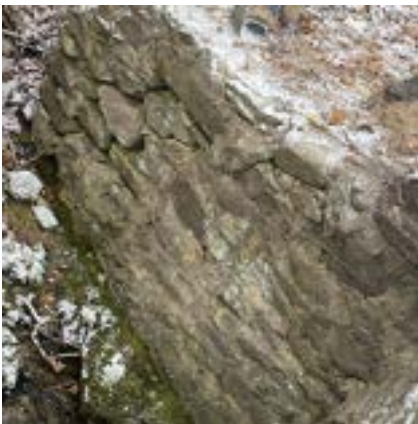
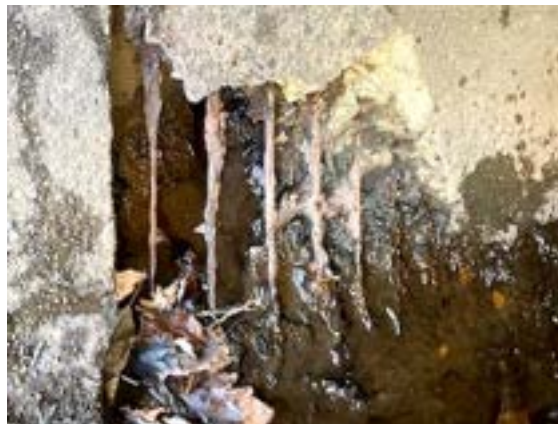
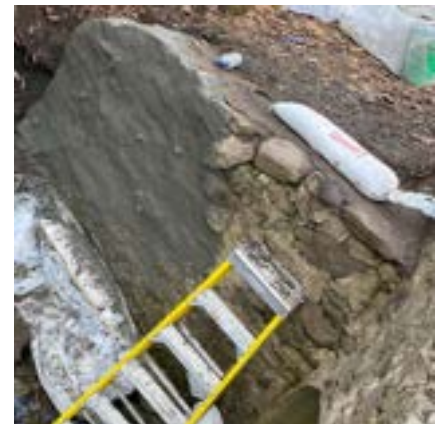
A culvert in Watertown, CT had a significant water flow and an erosion problem, leading to joint separation, invert deterioration, erosion issues, and headwall damage. The erosion had undermined the outlet which resulted in a disruption in water flow. With the age of the culvert, the inlet headwall was made with stacked stone. Over time, these stone headwalls can settle and become weak, starting to lose structural integrity. This culvert was located under a roadway which presented the additional challenge of traffic control. The separating joints caused concerns because the above roadway could be damaged by infiltration forming sinkholes.

HydraTech engineered a solution to address all of these issues. HydraTite seals were installed over the culvert joints for a permanent solution to the leaking separated joints. Five tons of riprap (large-diameter stone) were placed over the existing outlet void to prevent further deterioration and erosion by restoring natural water flow. The stone headwall was encased in two layers of concrete to prevent further structural damage and environmental erosion.

The job consisted of installing nine HydraTite seals that were 72" in diameter, the placement of five tons of riprap, concrete patching inside the pipe, and the concrete casing of the inlet stone headwall.

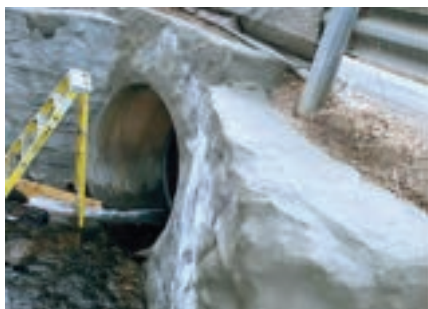
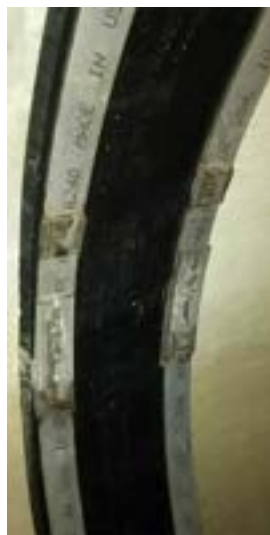
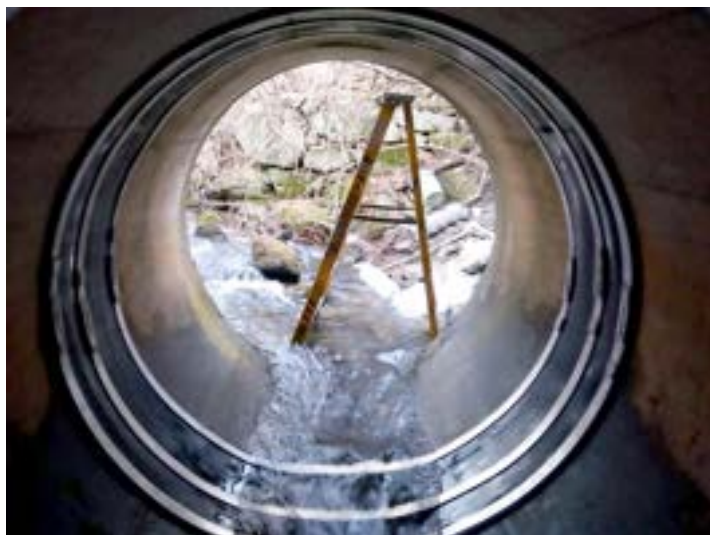
The HydraTite solution enabled a trenchless repair at a fraction of the cost of fully lining the pipeline or pipe replacement. The sealed joints and repaired invert restored the culvert's flow and helped stop damage to the above roadway by eliminating infiltration. All of this work was completed from the side of the road with minimal traffic disruption. The HydraTite seal proved to be an economical in situ repair solution.
