# INTERNAL PIPE HydraTite® JOINT SEAL

*Storm Sewer*

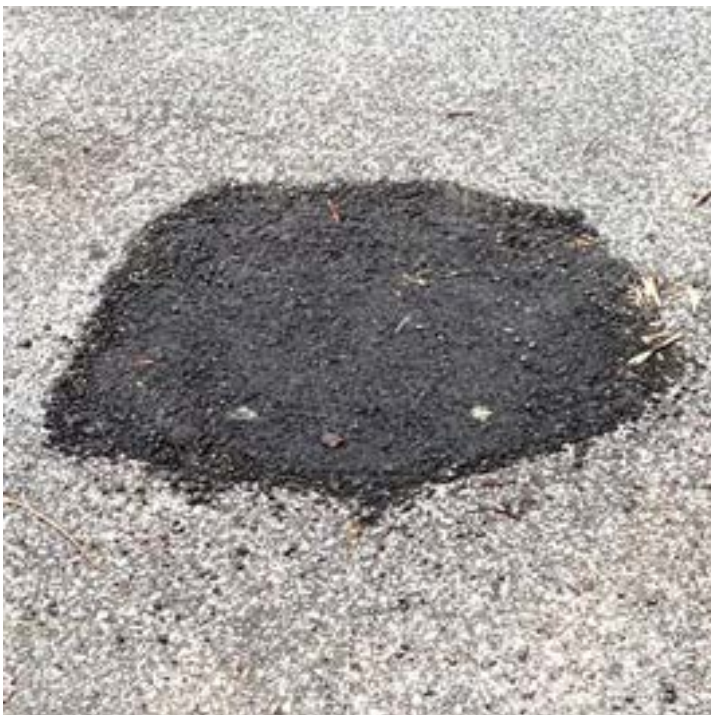
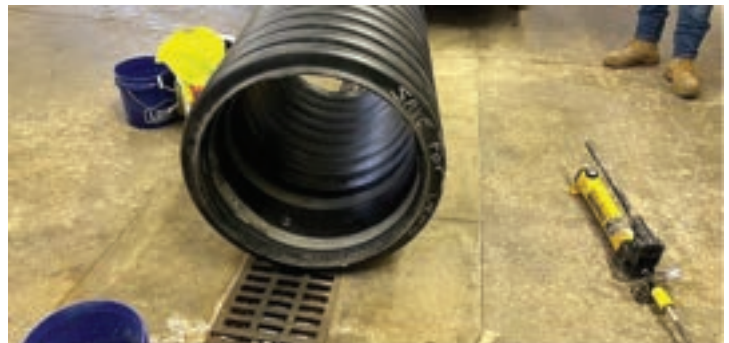
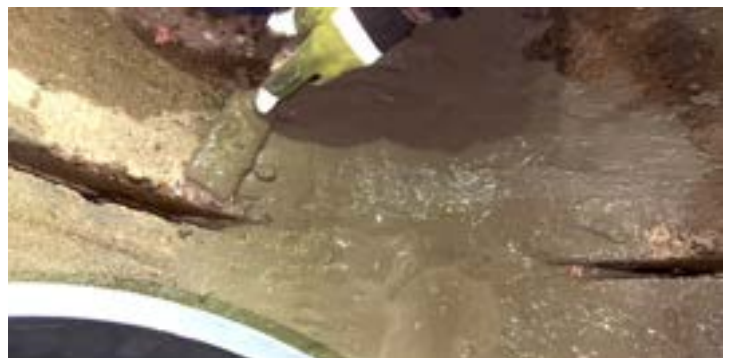
A township in northern Ohio found a small portion of a road that had sunk in. Pouring water through the sinkhole indicated which joints were the culprits as water entered through the separation. The sinkhole was patched, but a solution was needed that could address the underlying issue and prevent further infiltration without affecting the road above.

The gold installation package was selected by the township. With this option, the client is provided with the materials and oversight from a HydraTech Field technician. HydraTech gave a demonstration on a portion of pipe in a department building and then followed the township personnel out to the jobsite to oversee the installation of two seals. Water was pumped to make installation easier and a patch of concrete was added at the invert of both joints, creating a uniform surface for proper installation. Then the EPDM seal was lightly lubricated and placed over the joint. The retaining bands were then expanded and locked into place. The installation only took two hours.
