INTERNAL PIPE

# HydraTite®

JOINT SEAL

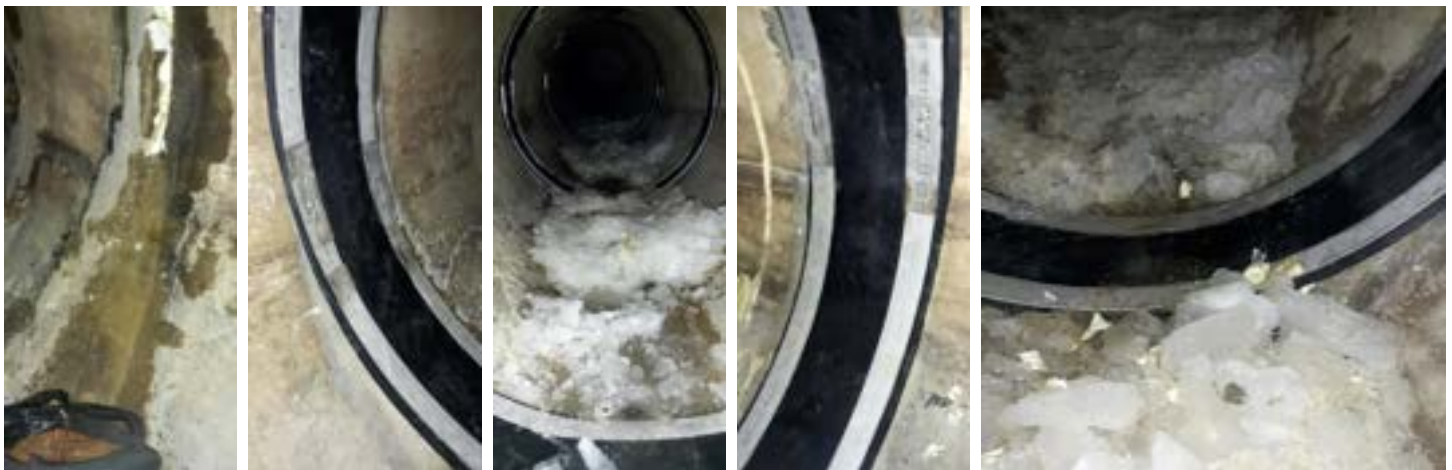
A 48" storm sewer that ran beneath a homeowner's driveway had shifted the joints had become offset. There was a stream of water in the pipe that was frozen, creating 4 to 6 inches of ice. The leaks at six compromised joints had to be eliminated to save the homeowner's driveway despite the ice.

Each joint location was cleared of ice and excess concrete. Then HydraTite seals were installed at 6 joints in the storm sewer that ran under a residential driveway in Cedar Rapids, Iowa.

The leaks at all 6 joints were eliminated. The seals will provide a lifetime of protection against infiltration and exfiltration for a fraction of the cost and time required for replacement.
