# INTERNAL PIPE HydraTite® JOINT SEAL

*Stormwater*

MnDOT discovered two drainage pipes that needed rehabilitation. Both pipes had two joints of concern, one had a diameter of 48" and the other had a diameter of 72". A trenchless option was preferred.

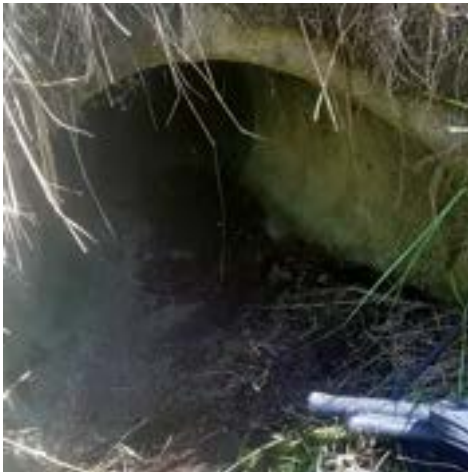
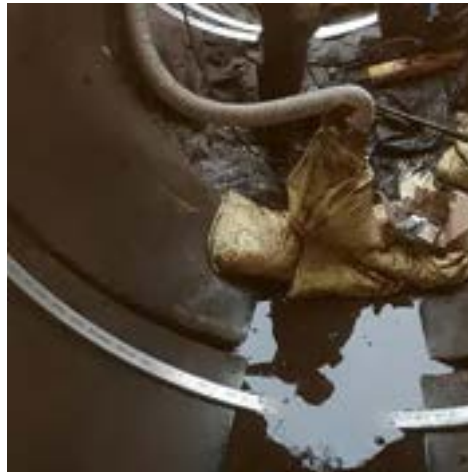
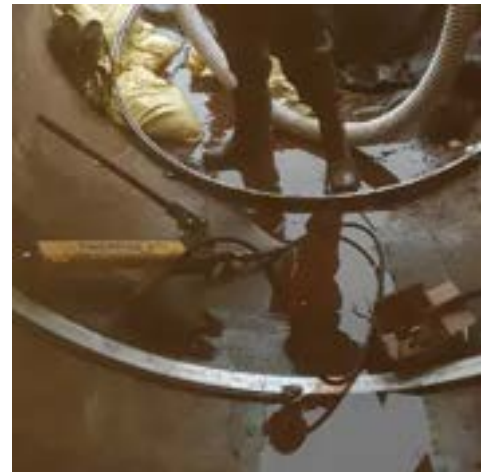
Mud was cleared away from the joints to ensure the seals could seal properly against the interior surface of the pipe. Extra-wide rubber seals were positioned over the joints in the 72" pipe and standard-wide rubber seals were installed over the joints in the 48" pipe. Two retaining bands were positioned into the rubber seals' designated channels. These bands were expanded utilizing a hydraulic expander and locked in place with wedges. The project was completed in a few days with a crew of only two people.

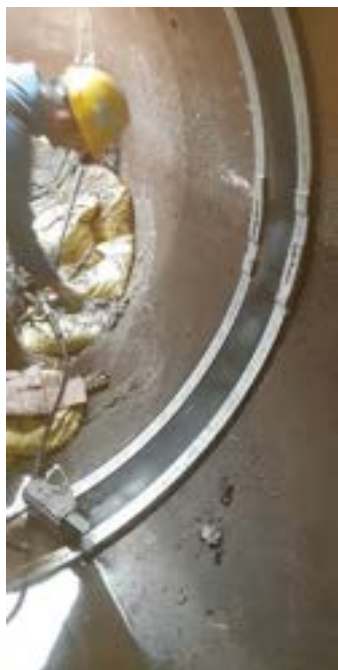
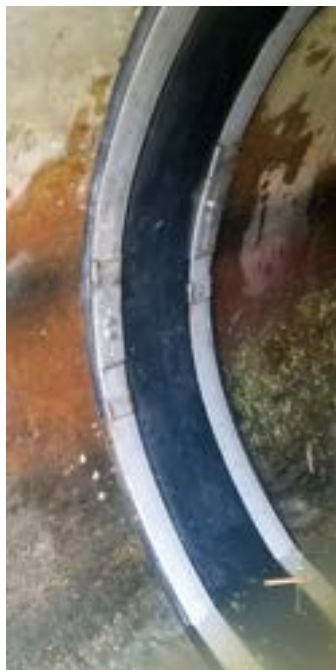
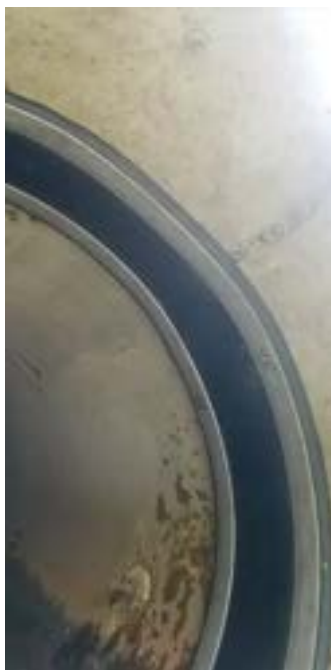
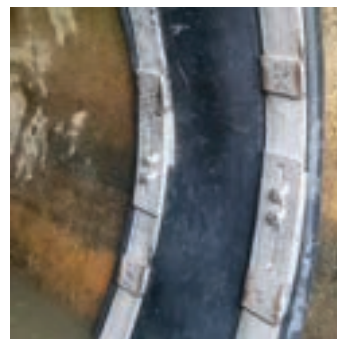
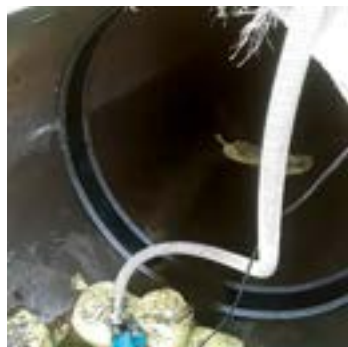
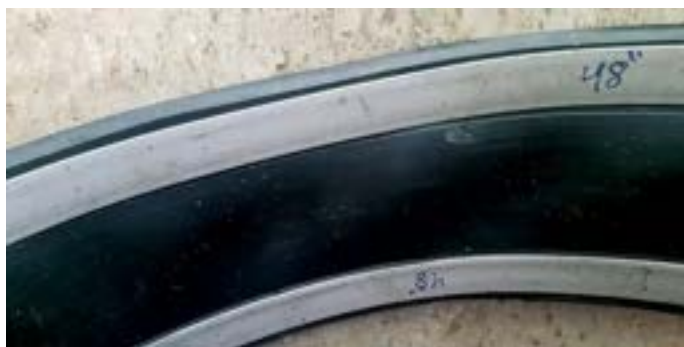
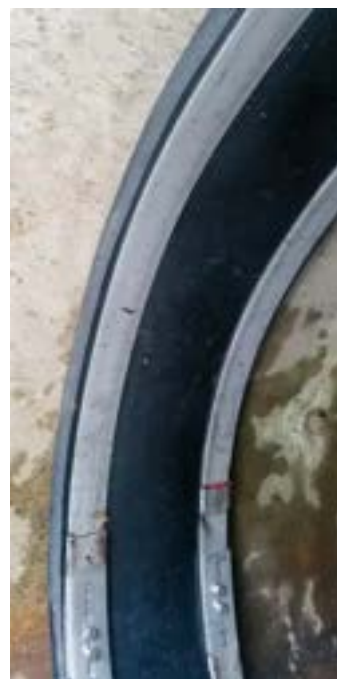
These two pipes were rehabilitated quickly using a solution that will last a lifetime. These four HydraTite seals fortified these joints against leaks.
