INTERNAL PIPE

# HydraTite®

JOINT SEAL

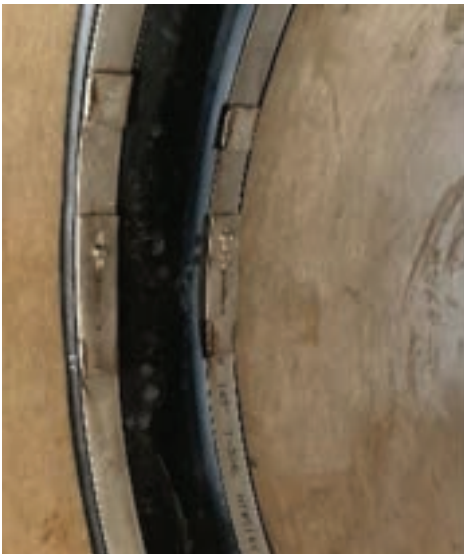
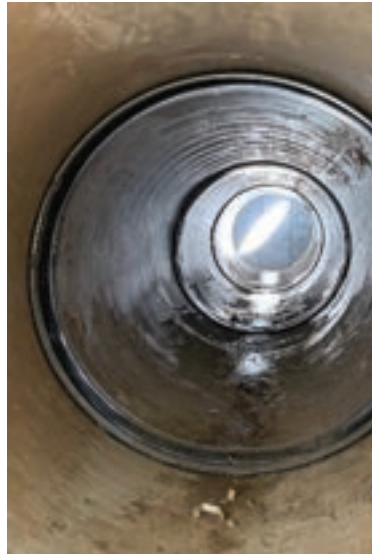
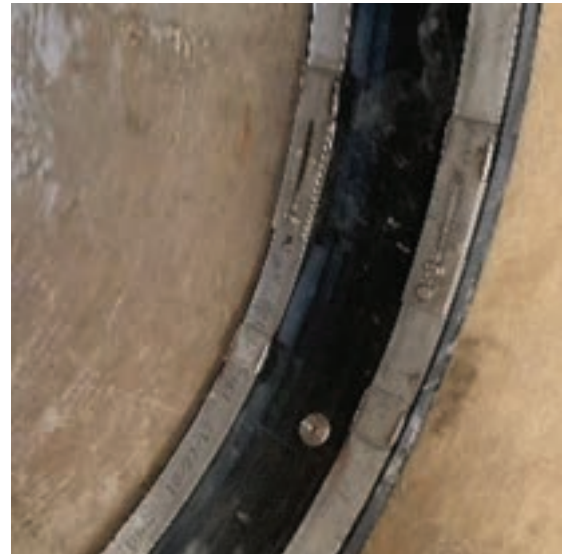
One of the three sections of pipe made a 20-foot drop and was only accessible by narrow stairs. First, the surface of the pipe near the joints was prepped to ensure a smooth surface for installation. The rubber was then put in position and the stainless steel bands were expanded to lock the rubber in place.
