# INTERNAL PIPE HydraTite® JOINT SEAL

*Municipal Drinking Water*

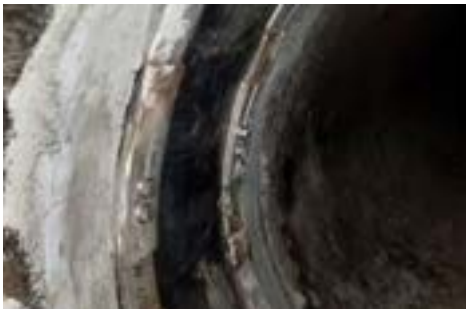
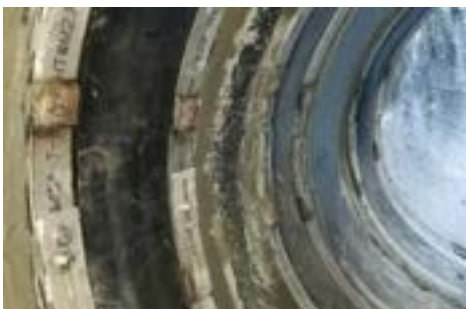
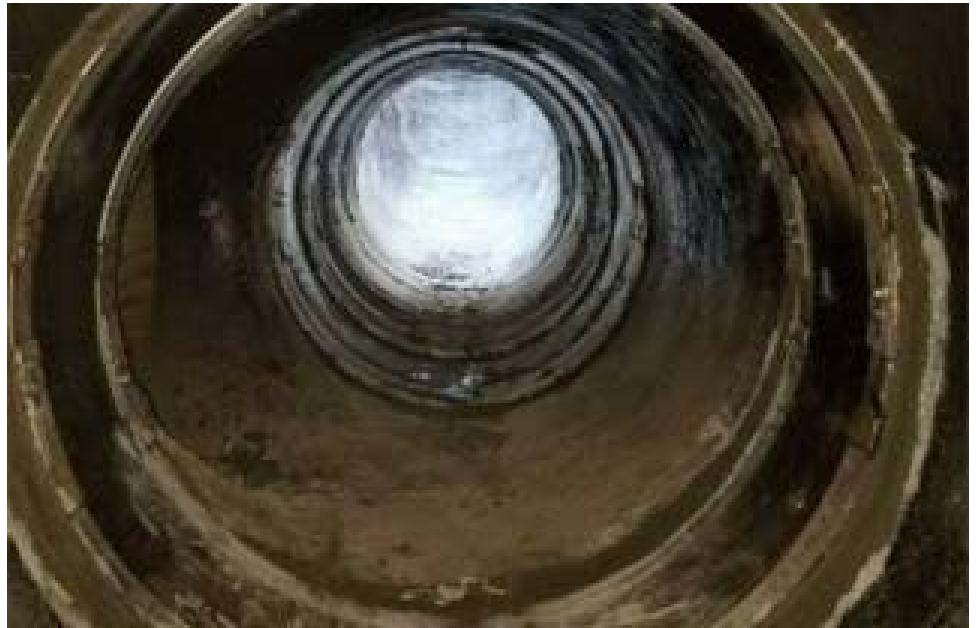
The challenge was to stop water leaking at the joints of a newly installed ductile iron pipe. The 30 & 36 inch ductile iron pipe had been cement lined and water was leaking in through the cement lining at the joints.

Surface prep included chipping out the cement at the joints prior to installation of the HydraTite® seals. After approval of the repair by the client, the HydraTite® seals were manufactured and installed.

Once surface prep was completed, nineteen seals were installed. The HydraTite® seals eliminated the infiltration of the water at the joints. Rapid installation including the surface prep had the entire job completed within four days.
