# HydraTite®

JOINT SEAL

## Challenge

## Engineered Solution

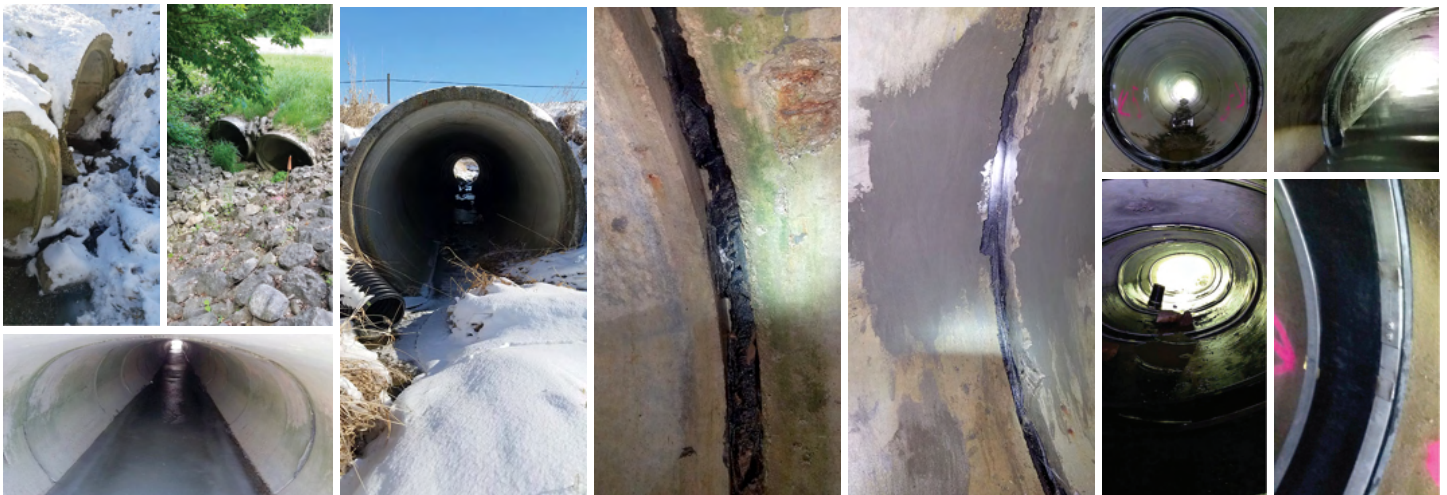
There were multiple sections of precast concrete culverts within ODOT District 7 that were showing signs of severe separation. The joint separation needed to be stopped so that the above roadways did not become damaged from infiltration/soil erosion.

Each pipe joint of concern was cleaned, smoothed with cement, and sealed with a HydraTite Internal Pipe Joint Seal. The installed HydraTite seals now prevent further separation of the existing pipe joints. This will help ensure infiltration does not cause soil loss under the existing roadways. The project was completed with minimal traffic disruption and at a fraction of the cost of other methods. This lifetime repair was successfully executed by HydraTech at 30 % below the engineer's estimate.
