INTERNAL PIPE

# HydraTite®

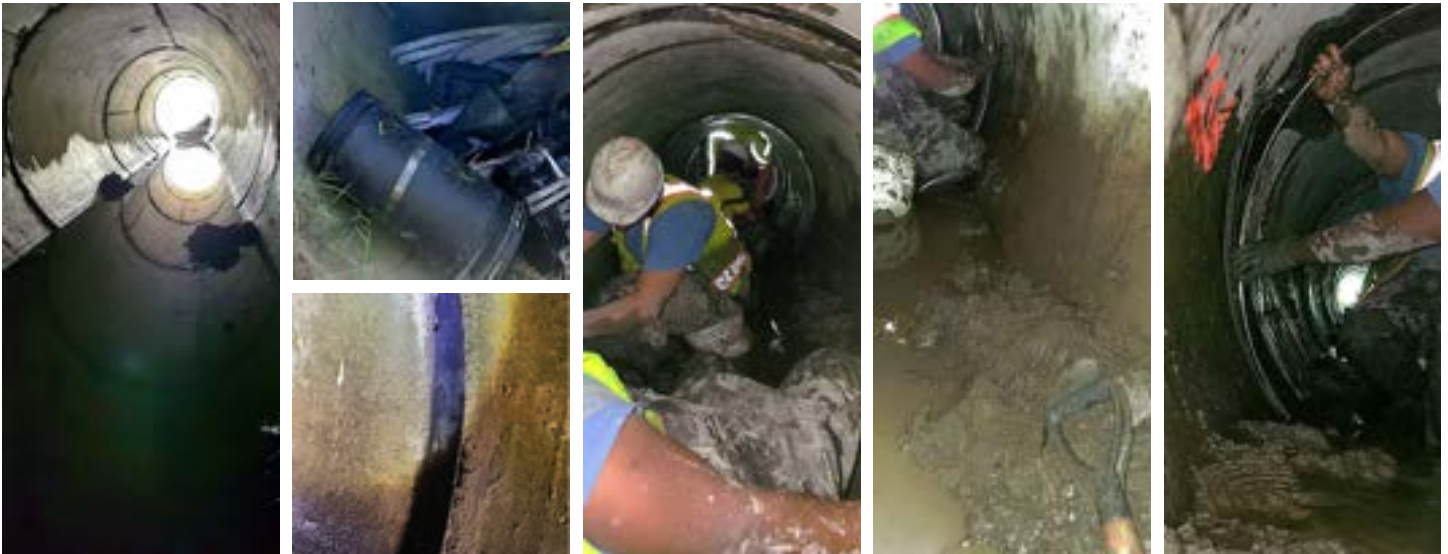
Five culverts had become less effective at managing the flow of water due to joints becoming separated and offset. Some joints had become offset by 2 inches. The result was groundwater infiltrating the pipe and carrying in the surrounding soil. This would lead to a sinkhole that would disturb the traveling public above by damaging the roads. Replacement would be an inconvenience for drivers as well and so an internal solution was needed.

HydraTite Internal Pipe Joint Seals were selected for this rehabilitation project. Many defective joints would have standard-wide seals installed over them, but the joints with more severely separated and/or offset joints would receive extra-wide and double-wide as needed.

65 seals were installed across the 5 locations. The seals with the largest diameter were 60", the next size down was 54", and the smallest was a custom-manufactured 39.5". The culverts were not entirely dewatered and in the pipe with the heaviest flow, the crew installed the seals in water up to their knees. 3 of the 5 pipes also had mud which had to be cleared away from the joints prior to installation. Due to HydraTite being a trenchless internal solution, no traffic control was needed. The entire process only took a small crew 2 weeks to finish.
