# INTERNAL PIPE HydraTite® JOINT SEAL

*Water / Irrigation*

There were concerns that an aging irrigation siphon in Washington would develop leaks at two joints. An internal solution was needed to prolong the life of this 13-foot diameter pipe.

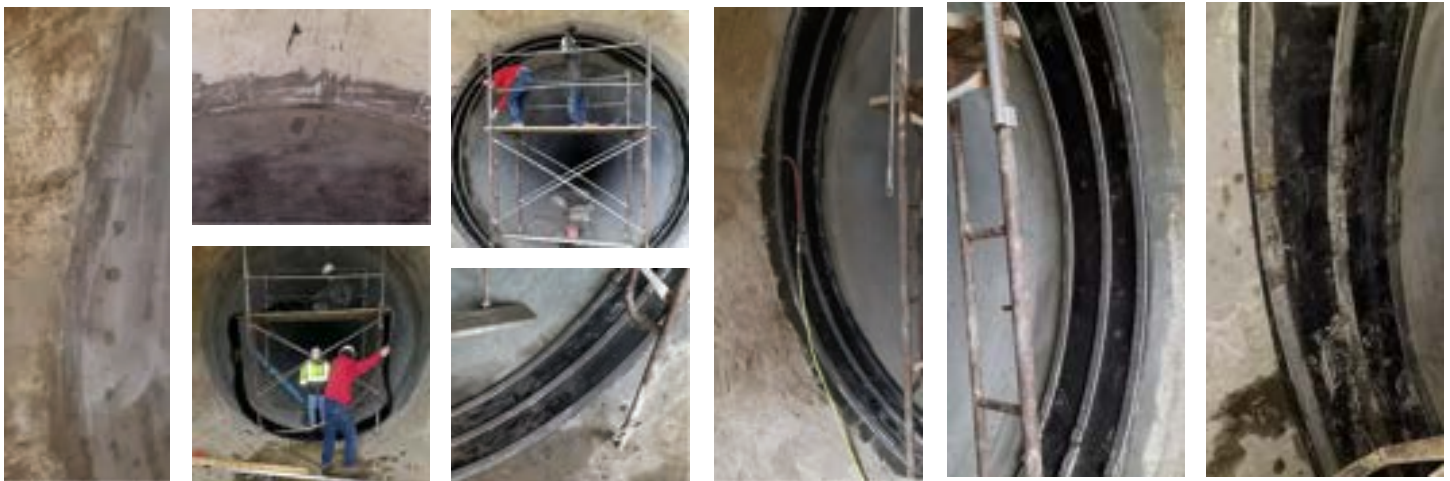
Scaffolding was set up and HydraTech began using concrete to fill small indentations near the joints. First, the rubber was positioned over the joint and then retaining bands were constructed. The bands were positioned in the rubber, expanded, and locked in place with a wedge. Finally, an air test was completed, ensuring that the seals would prevent the formation of leaks. These seals were installed in 2 days with a crew of only 4 people. This installation marked the end of a larger project that included 4 seals in total, two of which were installed on a previous outing.

HydraTech quickly installed these two seals, prolonging the life of this system at a fraction of the cost associated with replacement.
