INTERNAL PIPE

# HydraTite®

JOINT SEAL

Two locations had become compromised in a 21" RCP sanitary sewer that ran beneath a creek bed. The wall loss enabled root penetration and infiltration which resulted in additional volumes requiring treatment. A solution was needed that would seal the compromised locations in the pipe and stop roots from penetrating the pipe again.

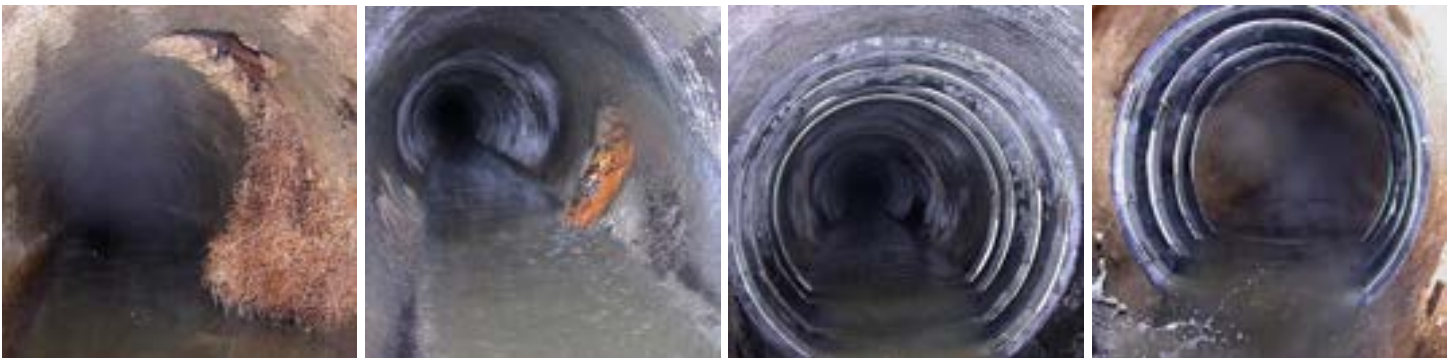
The joints were cleaned and the backing plates were placed over them. Six HydraTite seals were used to repair this pipe. Two interlocking sleeves were to be created using three seals each. These sleeves were installed over each point of repair using four retaining bands each. The repair was completed in one day without the need to bypass.
