# HYDRAWRAP

STRUCTURAL COMPOSITE REPAIR SYSTEM

## Challenge

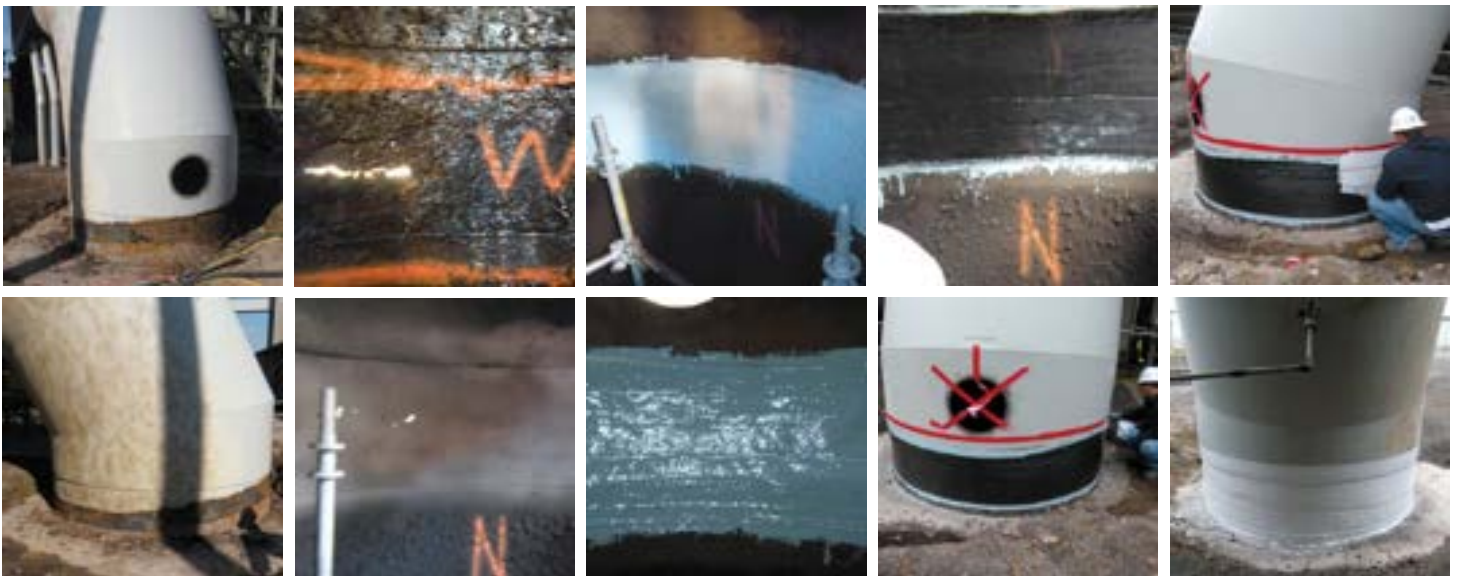
A 90" carbon steel pipe was suffering from severe corrosion damage at the soil-to-air interface in a cooling water system that was part of a power generation facility in Oklahoma. Some damaged portions were experiencing 100% wall loss. A structural solution was needed to seal the holes, stop corrosion and bring new life to the system.

The internal and external surfaces of the pipe were prepared and 7 layers of HydraWrap were applied to the inside of the pipe. Then 2 additional layers were applied to the exterior. Finally, the internal HydraWrap layers were coated in epoxy and the external layers of HydraWrap were coated with polyurethane to prevent damage from ultraviolet light.
