INTERNAL PIPE

# HydraTite®

JOINT SEAL

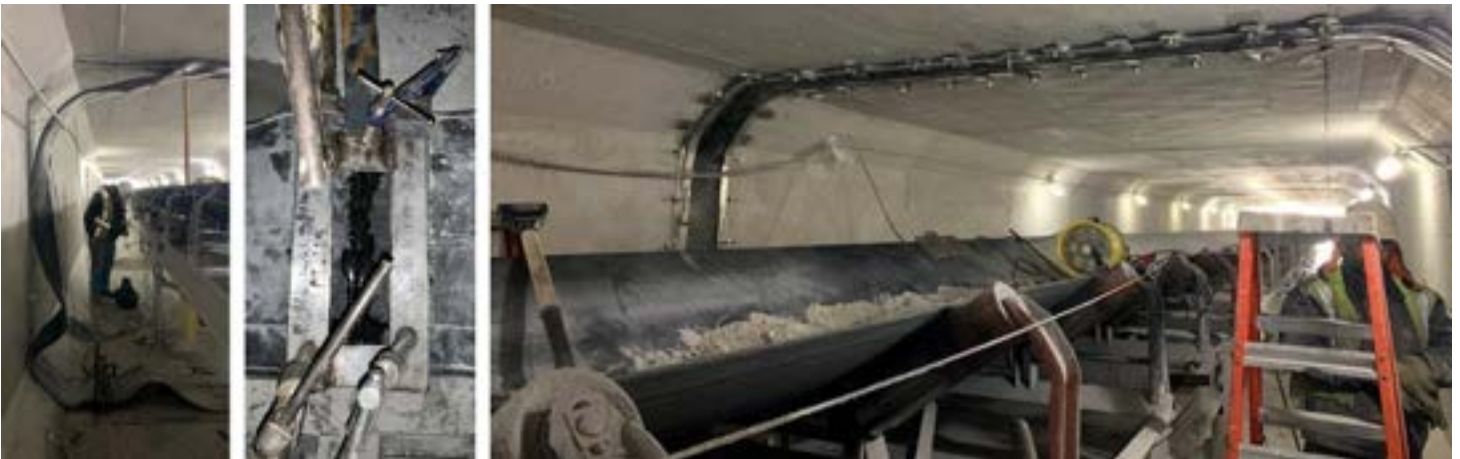
Groundwater was infiltrating a coal conveyor tunnel. The infiltration was at the joint of a concrete foundation in the tunnel. Damage from the water infiltration inside the tunnel was evident in the uneven settling of concrete sections. The water inside the tunnel also could damage equipment and was a slipping hazard for workers.

Once the surface prep was completed 5 box seals were installed. One seal was in an active conveyor tunnel and one was in an inactive conveyor tunnel the other 3 were in an access tunnel. The Box seal for the active tunnel was installed during an outage, as it was a critical work item. The job was completed in approximately 3 week and eliminated all infiltration.
