**Market**  
DOT

Along State Route 350 in Clinton County, Ohio (ODOT District 8), a twin-barrel culvert, two 27-inch pipes side by side, had developed joint separation and a sinkhole near the inlet. A HydraTech Field Services inspection found six joints in each barrel (12 joints total), offsets averaging about 1.5 inches away from the sinkhole joint, and a roughly 5-inch gap at the joint under the sinkhole (about 7–10 feet from the inlet). Three to four inches of dirt and debris lined the pipes, with heavier buildup near the sinkhole, blocking access for repair.

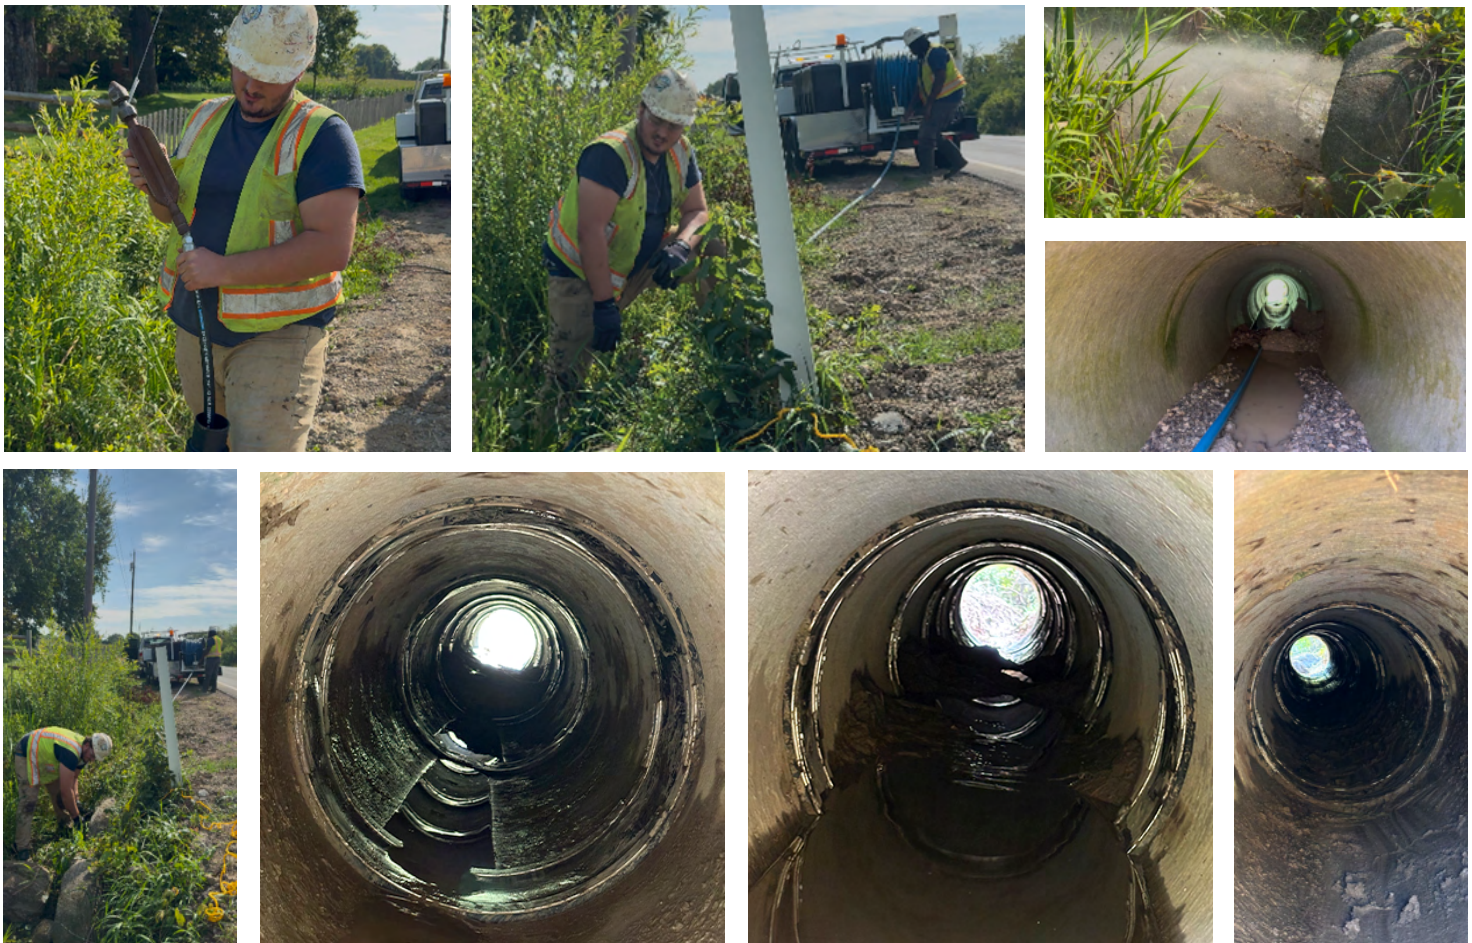
Jetter cleanout re-established workable access through both 27-inch barrels, and HydraTite seals were installed at all twelve joints, including a Double Wide seal with backing plate at the sinkhole joint. The work was completed once the internal cleanout and joint-seal repair were complete, both without excavating or replacing the twin barrels under the state route or disrupting traffic.
